An Investigation into the Handlebar Failure that Occurred in the Australian Men's Team Pursuit race at the Tokyo 2020 Olympics

Date of Incident: 2nd August 2021

Location: Izu Velodrome, Tokyo, Japan

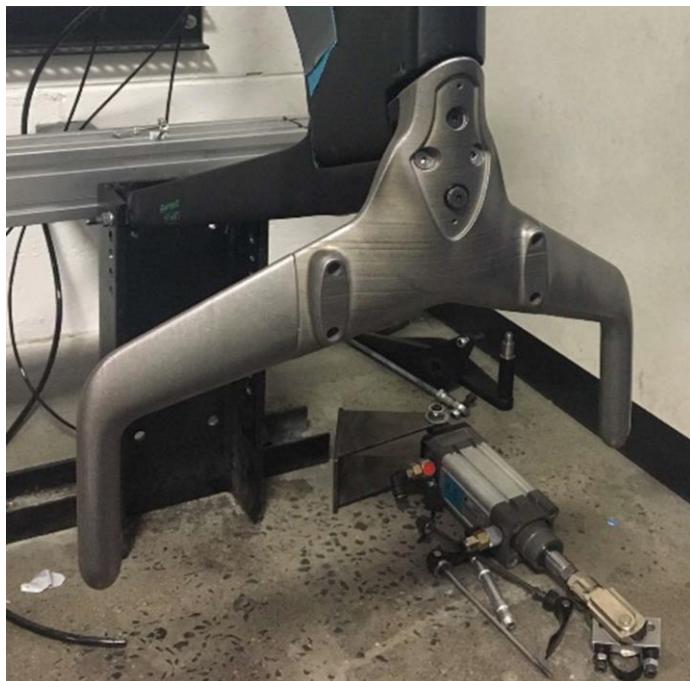
Figure 6: Base Bar CA-06 mounted in the Test Rig

50. Base Bars were tested using air rams, a controller and a data recorder in static force mode and in fatigue alternating force modes. Test forces applied, were resisted against a machined mounting fixture which replicated the top of the bike steering fork. Following the successful completion of all the testing to meet the Specification, as aurally amended by the Australian Cycling Team Performance Systems Manager, Bastion Cycles issued Test Report TR-CA-06-001 dated 17 July 2019. That Report forms [Annex F](#). The test jig with a Base Bar mounted is depicted at Figure 6.

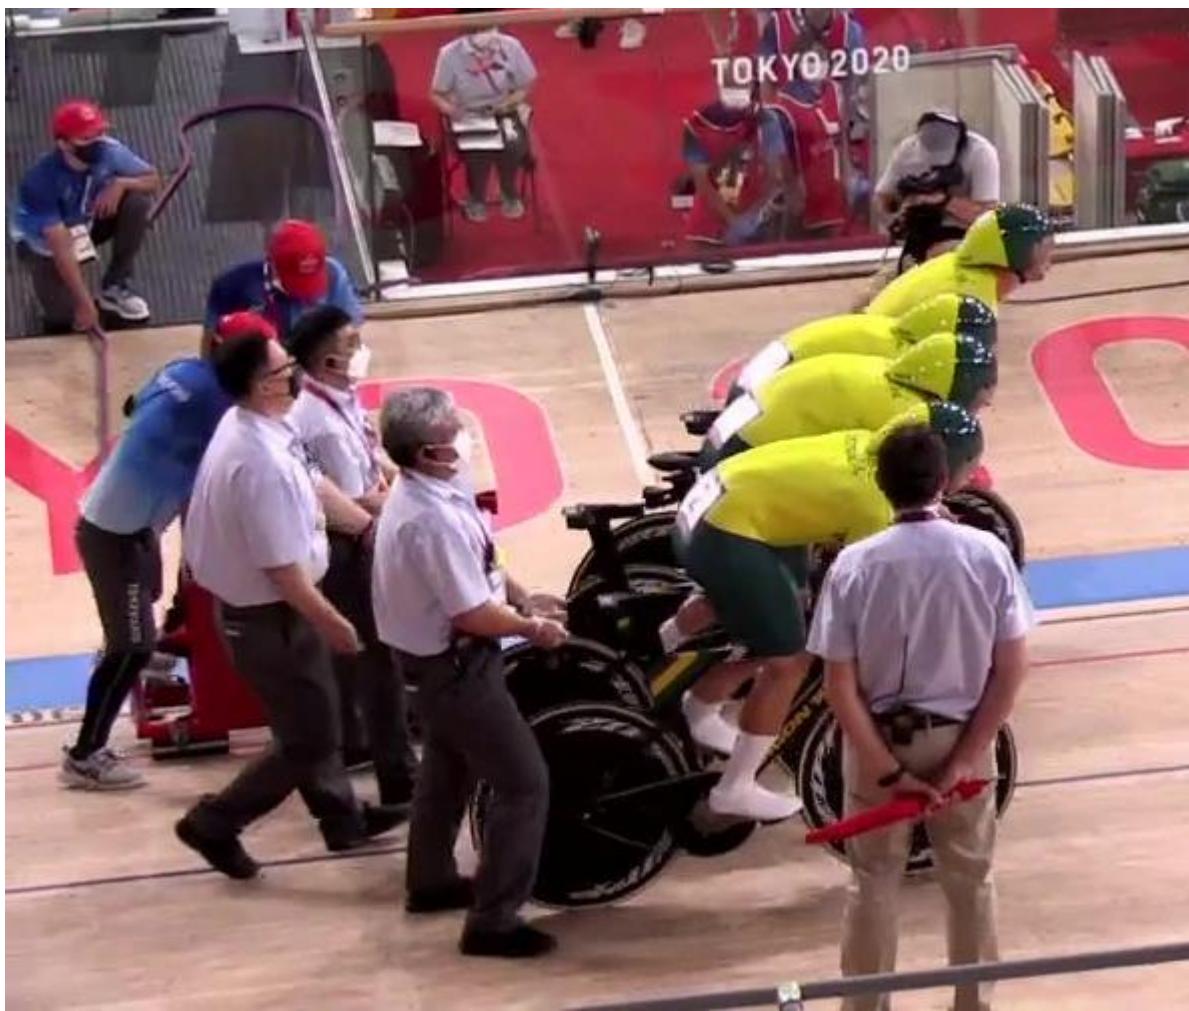
Figure 7: Athlete rider on start release, Tokyo 2020

59. In use, the most severe forces applied to the Base Bar occurred immediately after the release at the start of a race. The starting position shows the athlete rider standing, rider weight forward over pedals, leveraging upwards on the Base Bar to achieve the maximum pedal force with pedal torque forces recorded on the infocrank system. As the Base Bar was used by many athlete riders, this starting torque was repeated and at varying values. Appendix B, Figure 33 of the Bastion Base Bar Failure Investigation Data Collection gives a clockwise torque of 410Nm from the left pedal and an additive clockwise torque of 95Nm from the right pedal at start: subtracting the upwards force on the one pedal from the downwards force on the other pedal results in a downward force which, less the rider's weight, must be balanced by an upward force on the Base Bar.

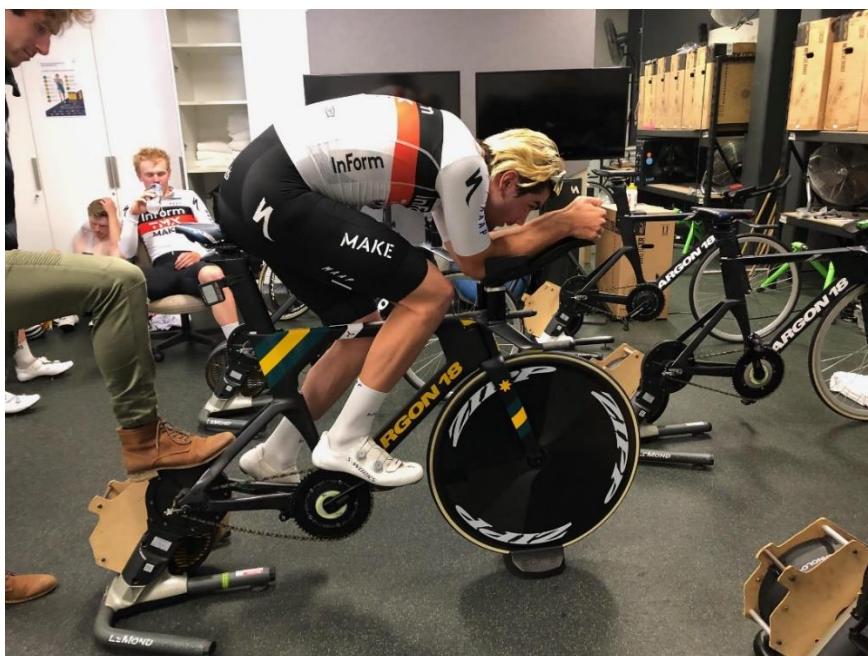
Figure 8: Isometric Exercise Riding Position

65. **Isometric Exercises.** Athlete riders complete isometric exercise to prepare their muscles for maximum effort, all at a particular joint angle; when on training camps and at the 2020 Tokyo Olympics, these exercises were completed on the racing frames and the Coach estimated some 324 repetitions for all four Base Bars. The force at the Base Bar to be reacted by the mass of the athlete rider, the seat and the muscle-to-pedal force was extracted by the Australian Cycling Team (Annex I). On examination, the value extracted was found to be in error, in that not all of the contributions to a rigid body equilibrium had been included. The error was traced to inadequate process and checking.

66. Isometric exercise forces did not constitute the critical design case but should be considered when a fatigue spectrum for AusCycling is being generated.

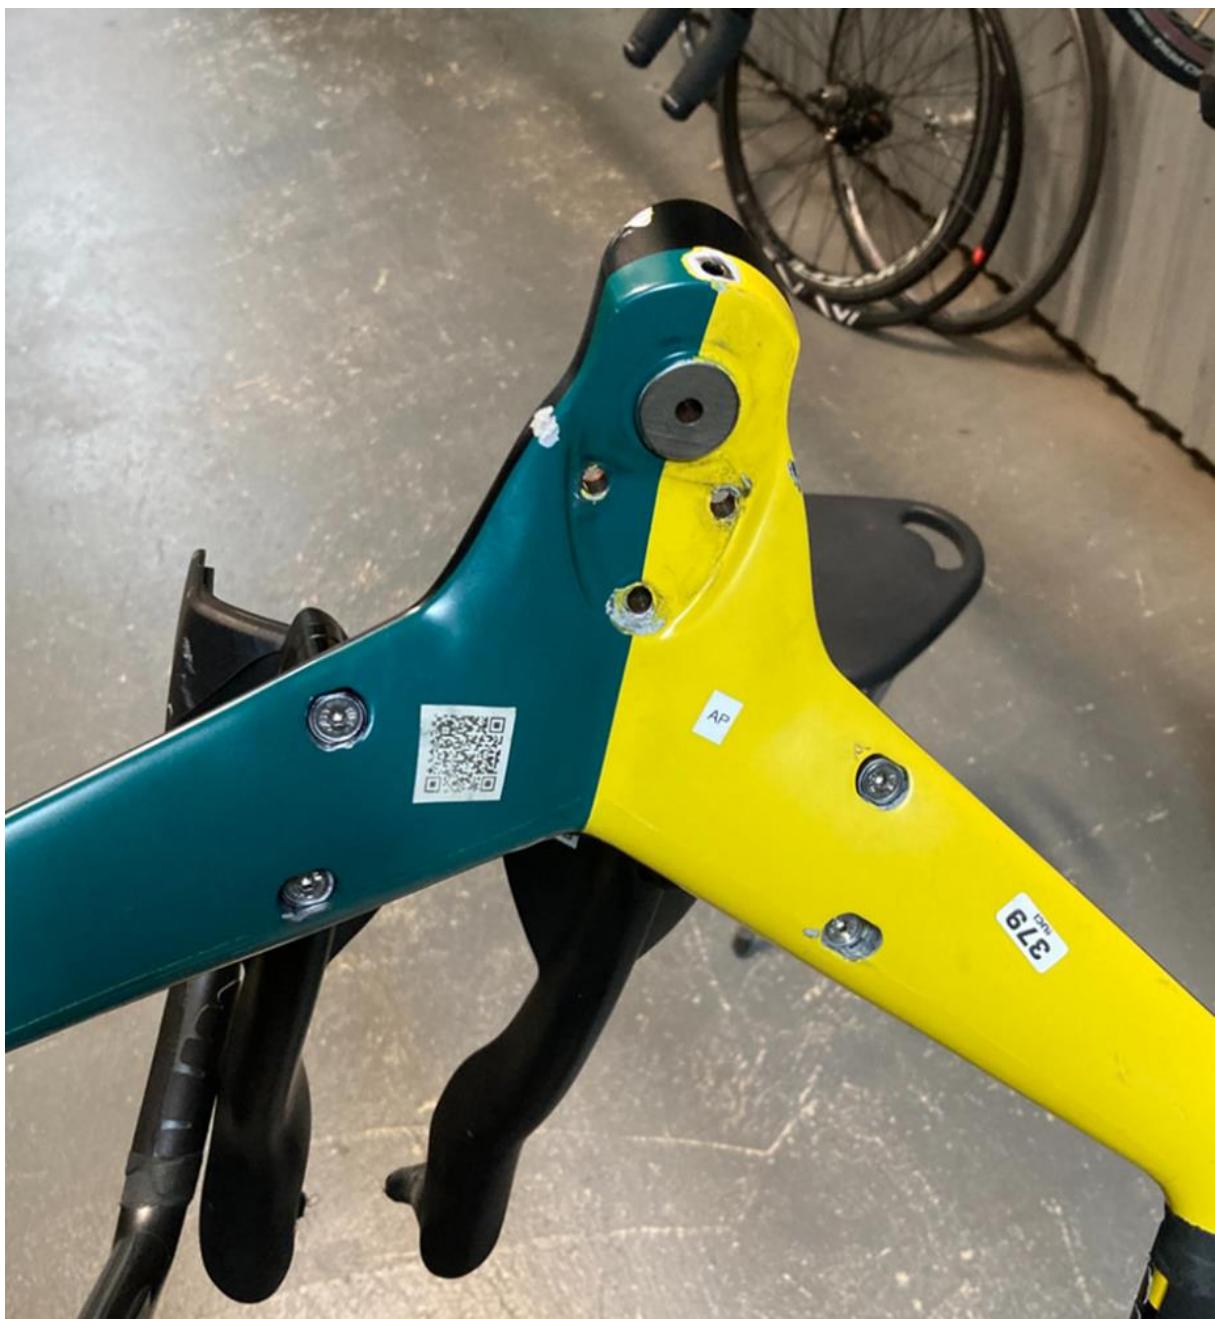
Figure 14: Number One Base Bar with paint missing from the front bolt hole

84. When the Number one Base Bar was painted, the under-surface cover was complete including the Base Bar to steering fork mating surface. Annex L was the paint plan used. Base Bars Two, Three and Four were painted differently with no traceability of the relevant paint plans. Significantly, the steering fork mating surface for Base Bars Two, Three and Four were not painted and left as printed. On examination during the investigation, paint forward of the forward bolt hole on the Base Bar One was missing. Complimentary, but less significant is the missing paint around the two lateral holes.

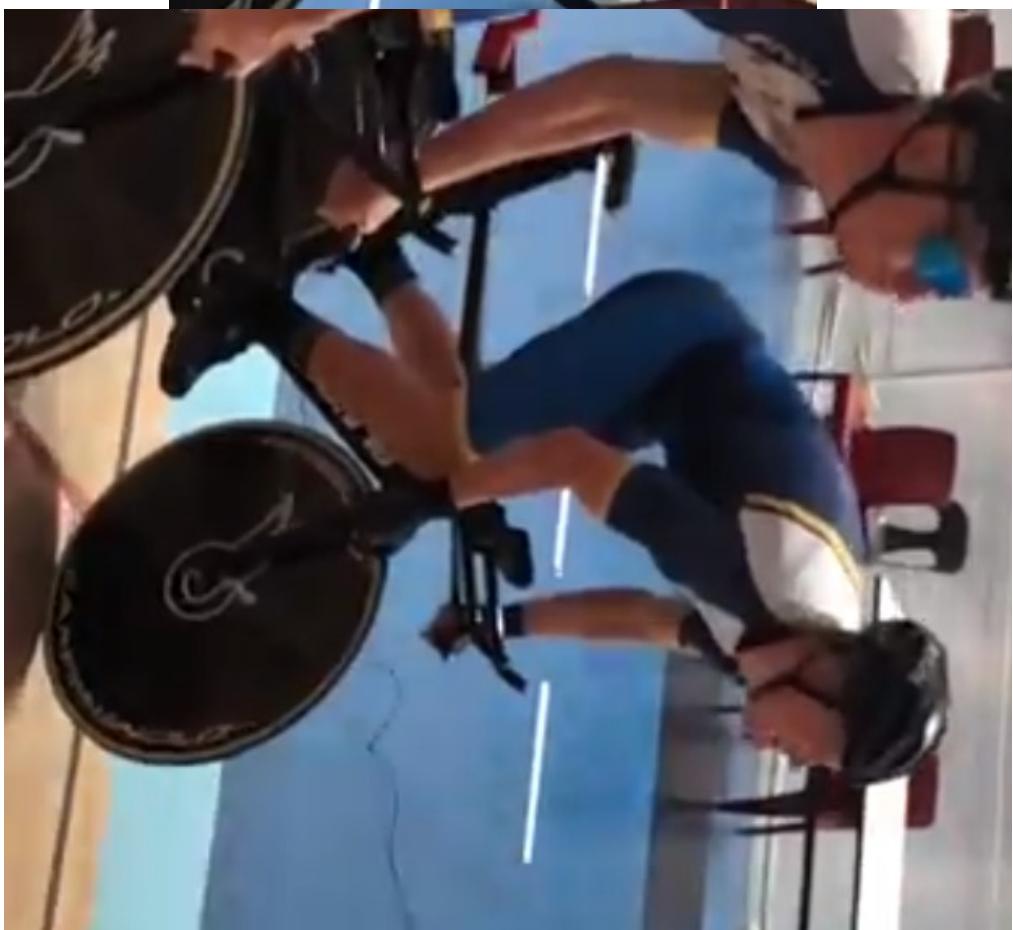
Alex hits his the top of knee/front of thigh on the rear edge of the basebar. The hitting causes the front wheel to lift and could cause a fall.

Proposed Solution

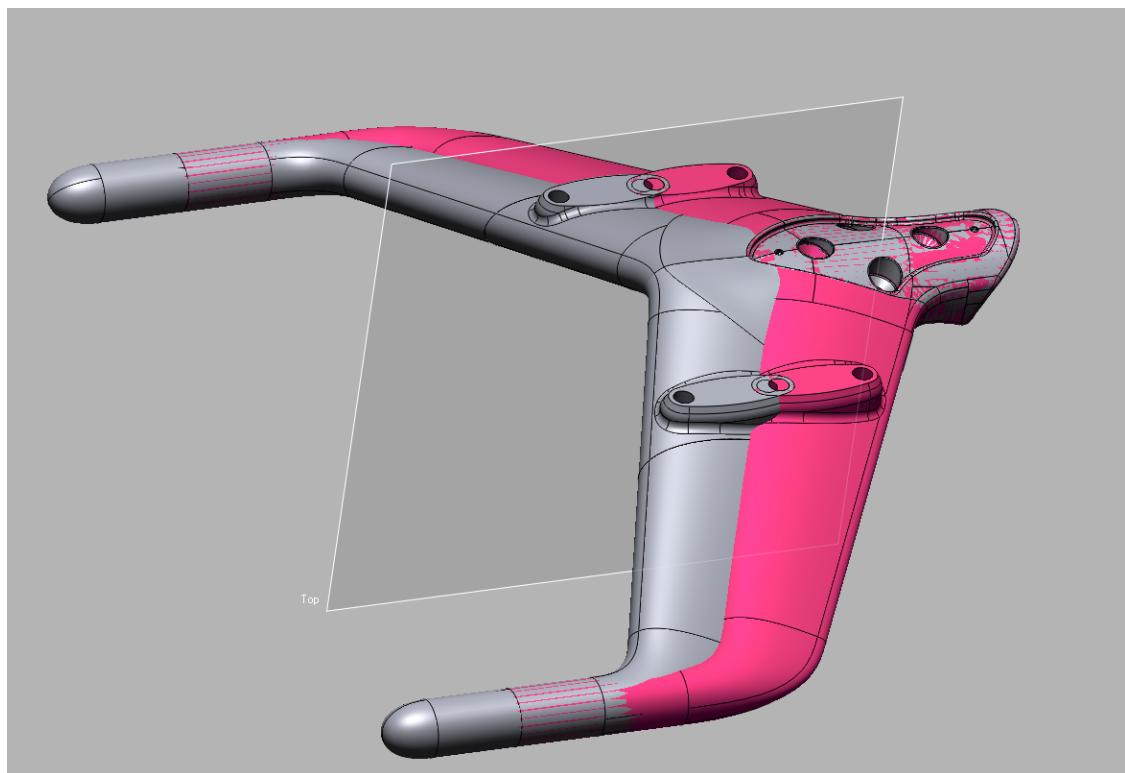
Figure 4 - Overlay of Argon18 standard pursuit base bar (pink) vs. Bastion CA06 design (grey)

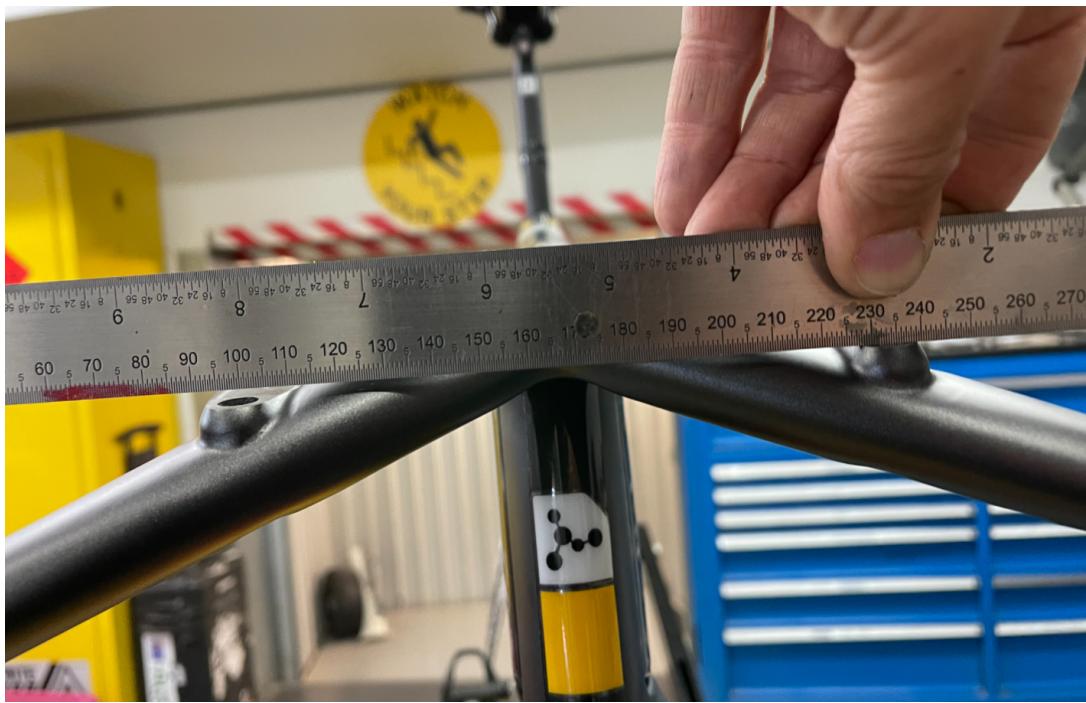
Figure 7 - Bastion bar #2 extension mounting surface issue

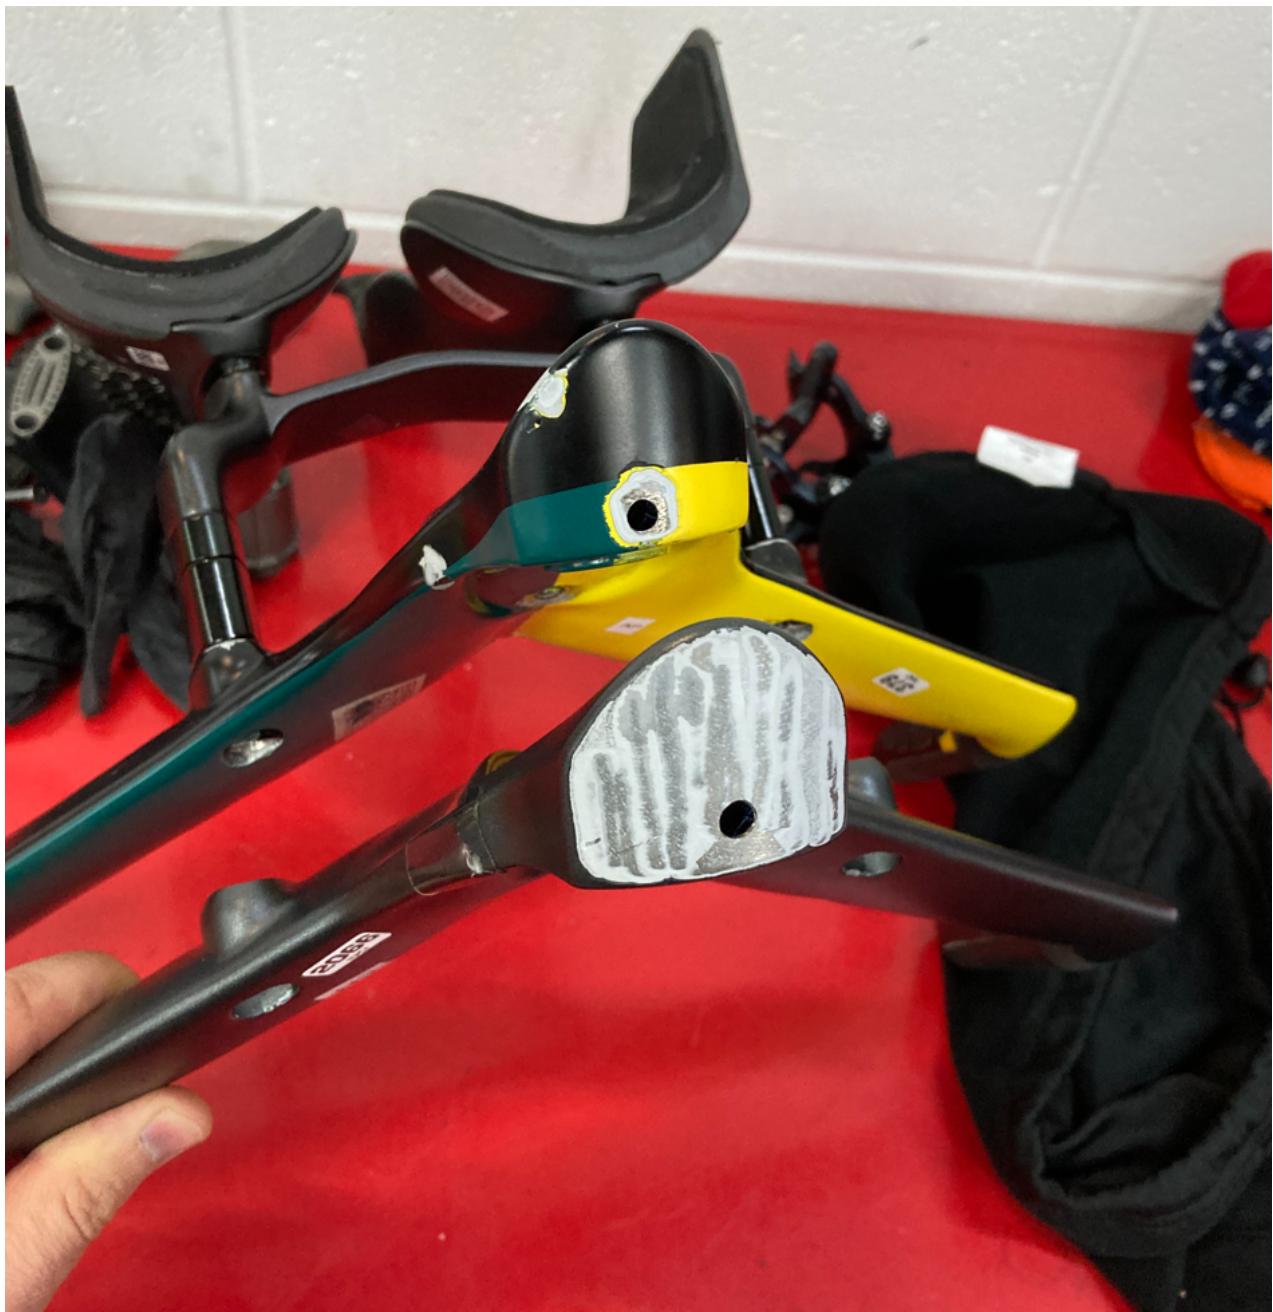
Figure 9 - Bars #1 (top) and #2 (bottom) showing rear surface, no breather holes. Inspection holes drilled by ACT after Tokyo qualifying incident to confirm oxidisation

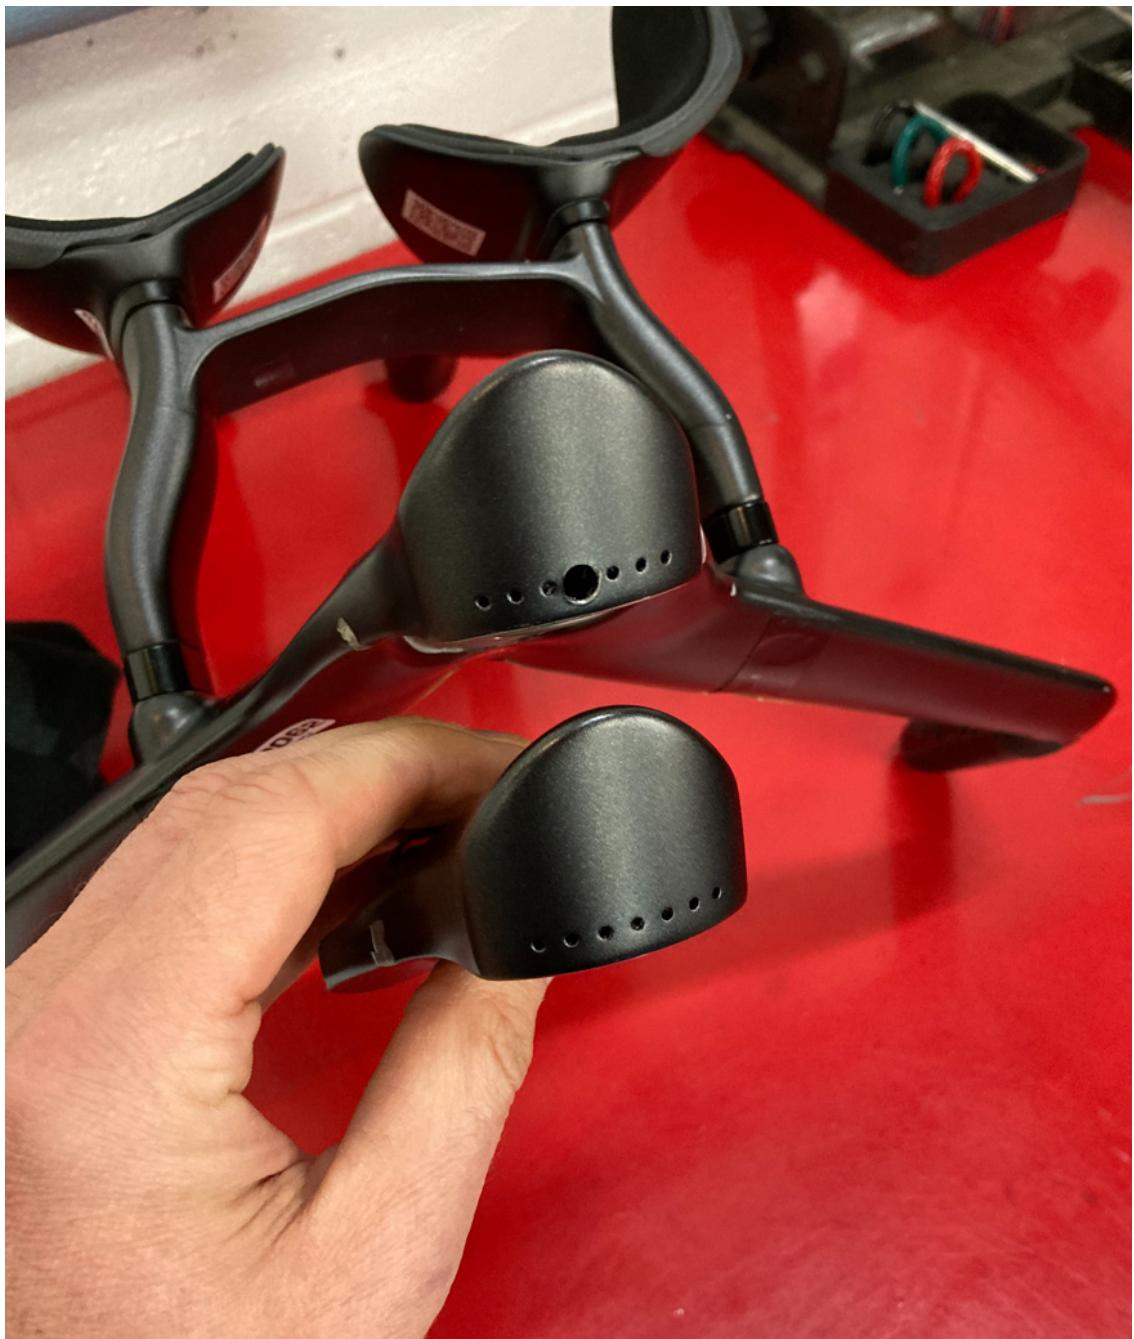
Figure 10 - Bars #3 (top) and #4 (bottom) showing presence of additional breather holes. Drilled hole in bar #3 by ACT to inspect oxidation. Bar #4 is that which failed under Alex Porter

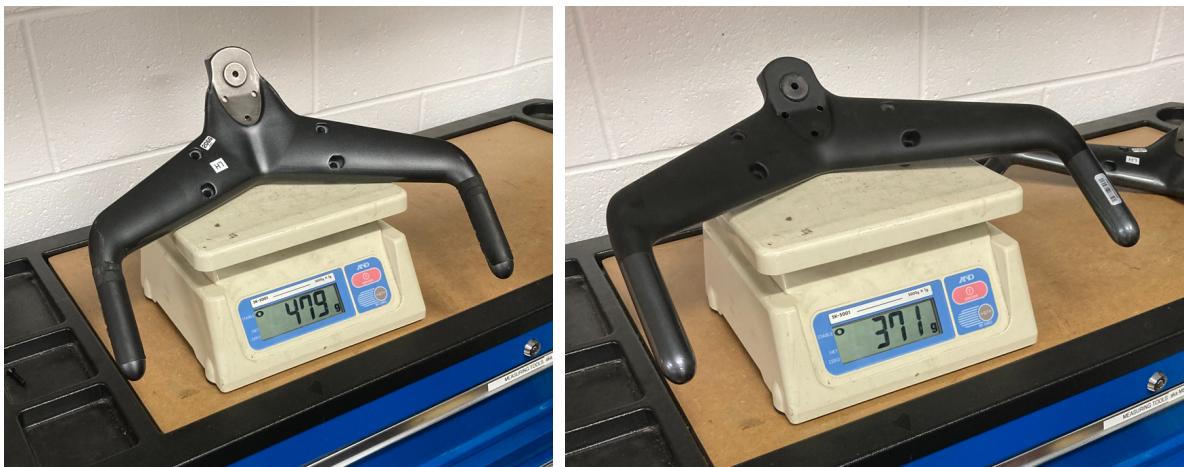
Figure 11 - Bastion (L) vs. Argon standard (R) base bar weights

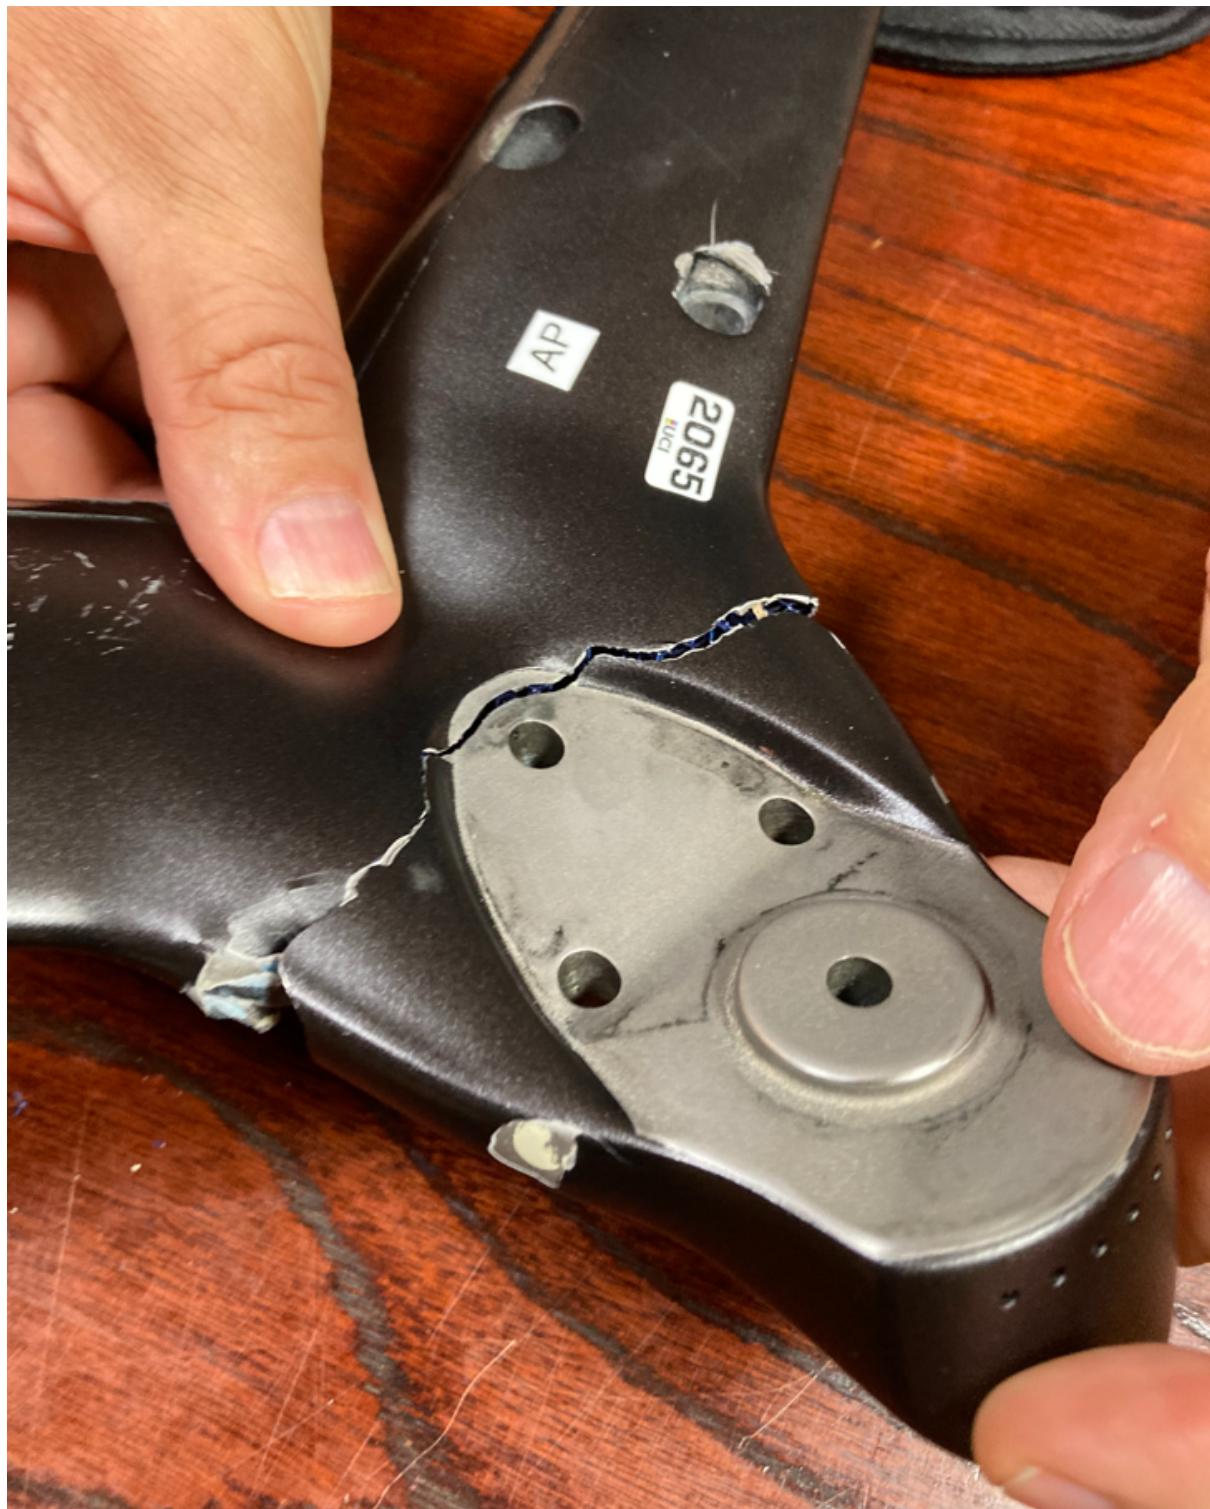
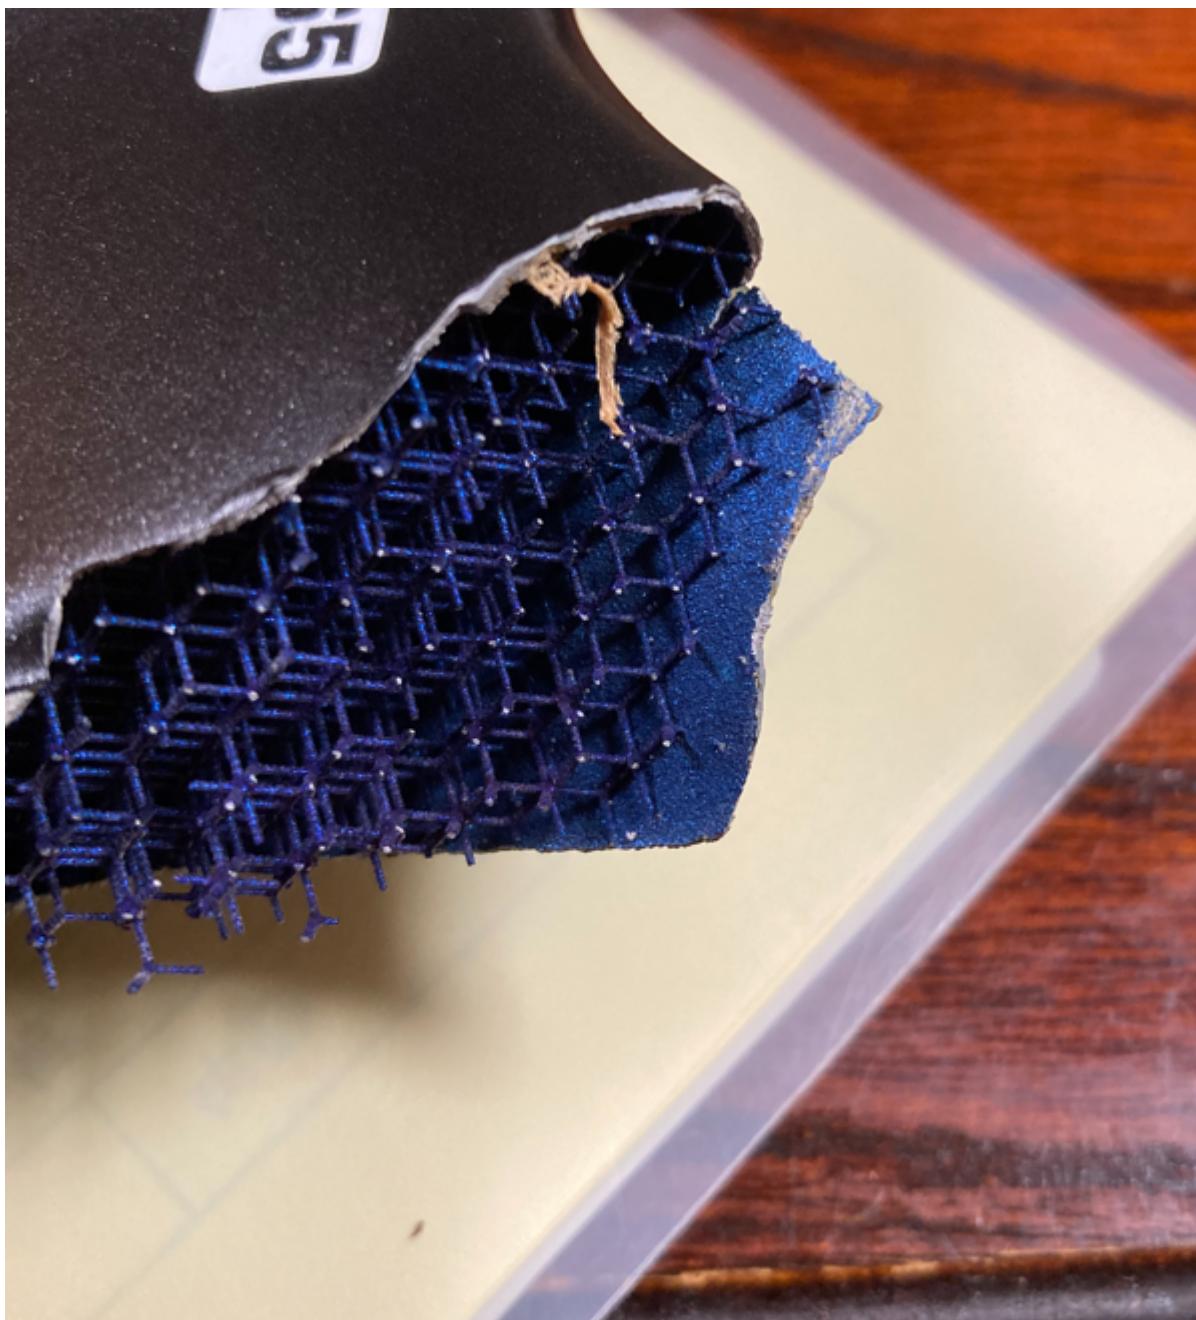
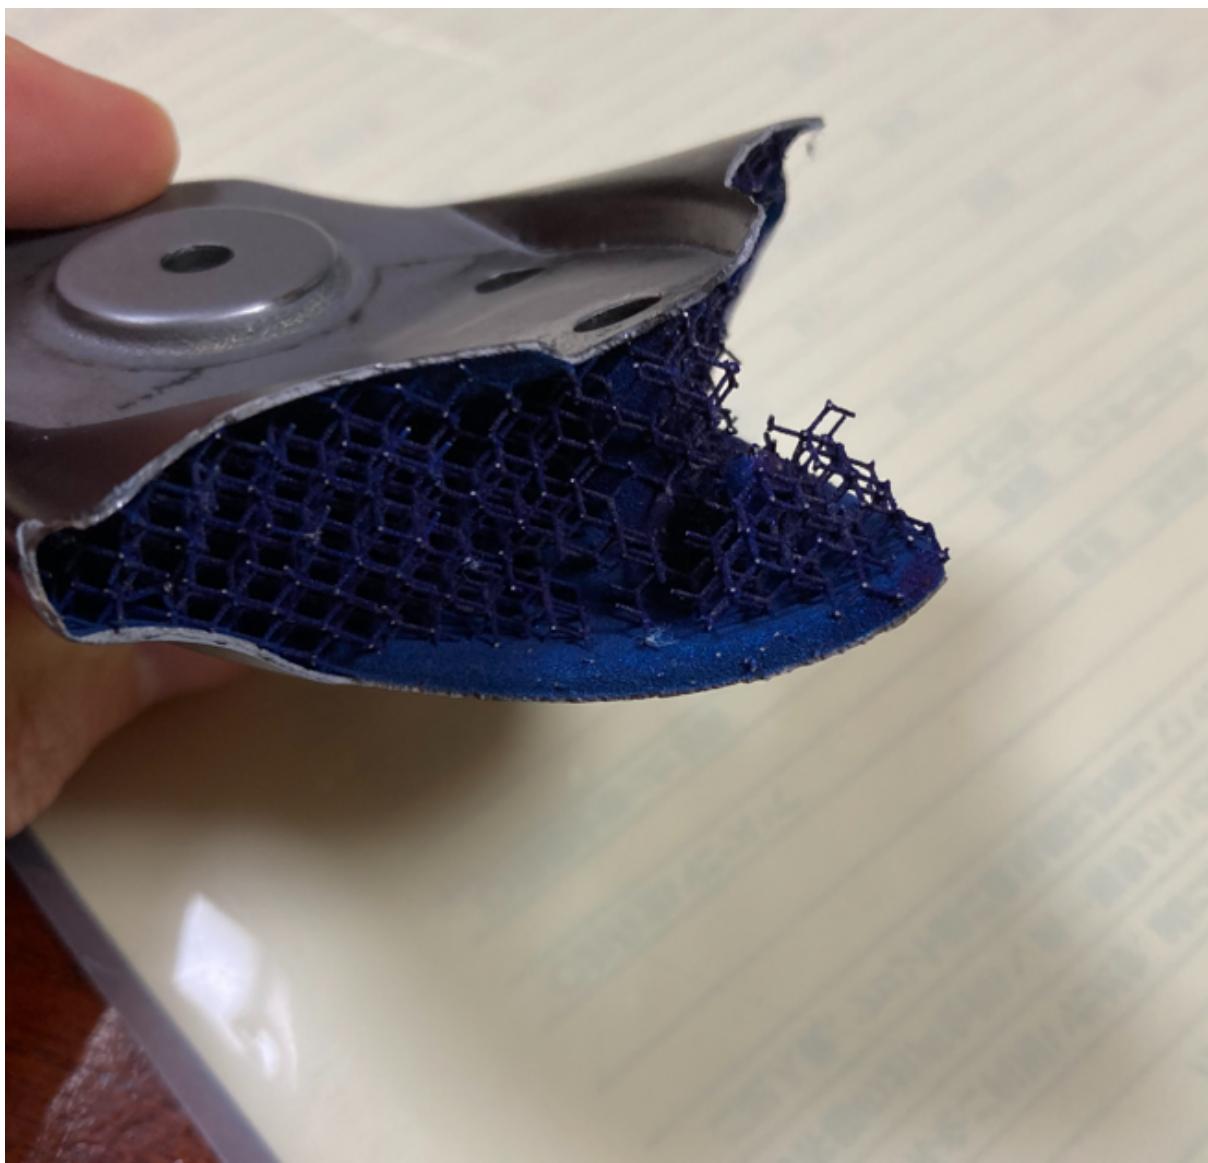
Images of broken bar #4

Figure 12 - Bar #4 both parts held together

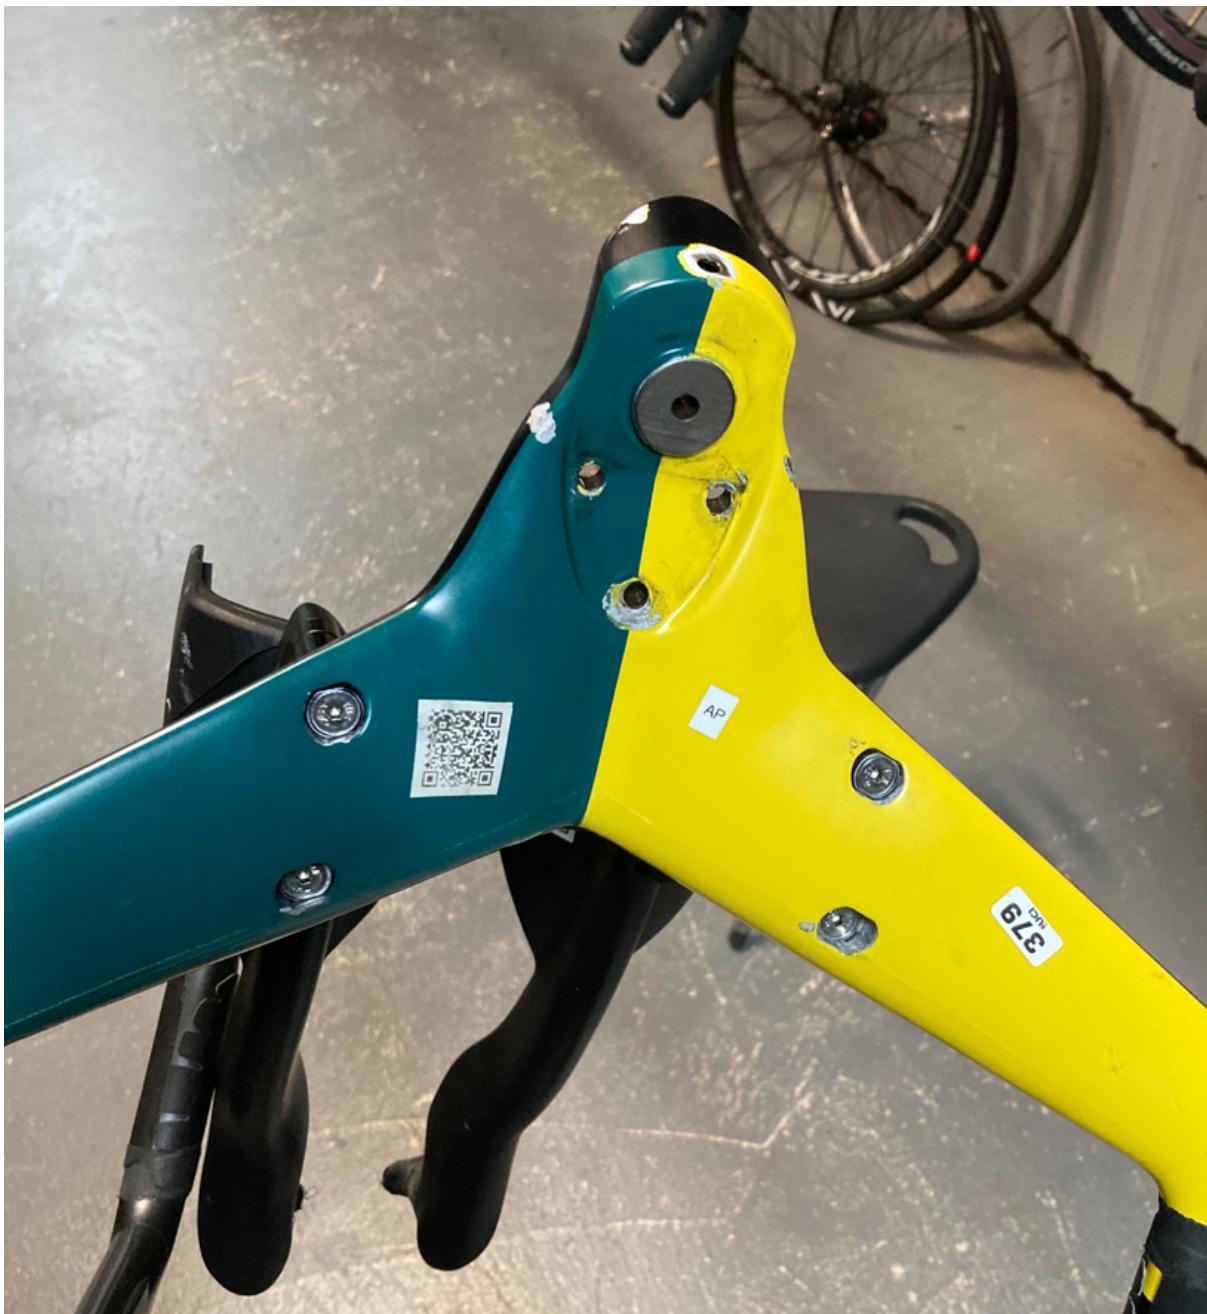
Figure 17 - Bar #1 - original, delivered in 2019. Painted underside to match livery of standard Argon 2020 base bars. Note paint worn away at front of mounting face with fork crown. Kept as a spare and used only by AP in 2nd attempt at qualifying ride

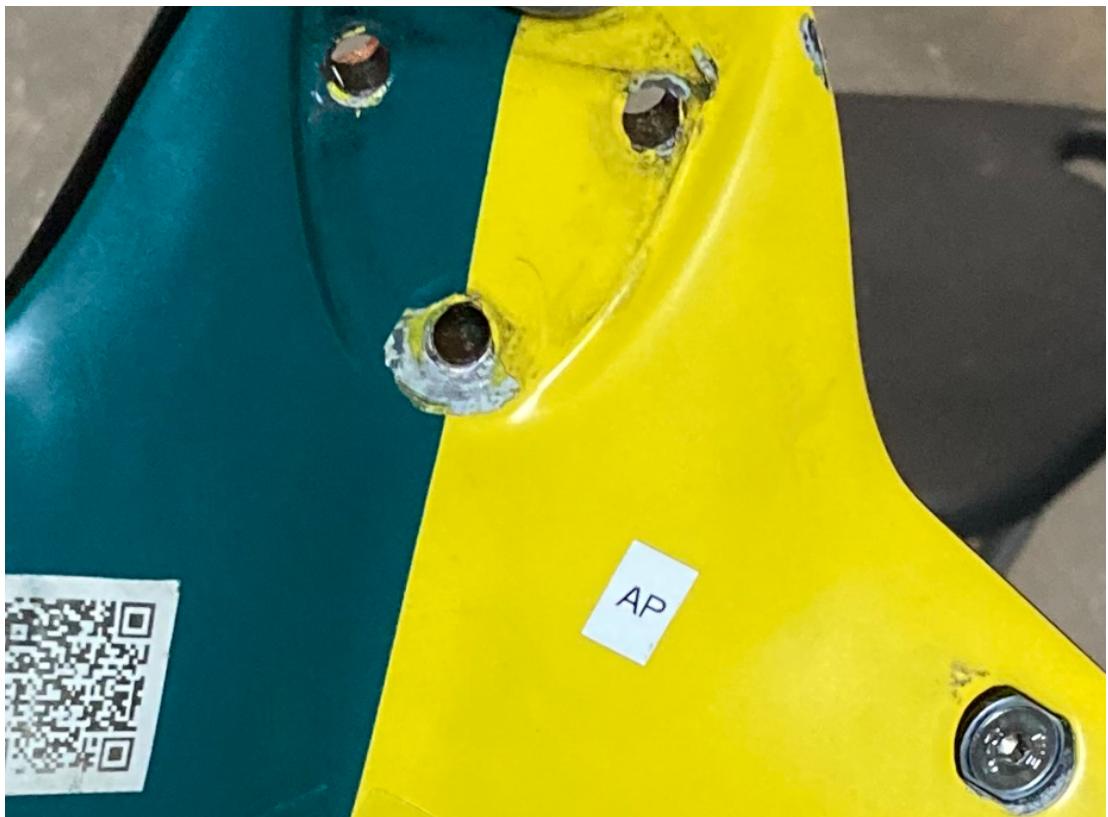
Figure 18 - Closeup of paint worn away on bar #1

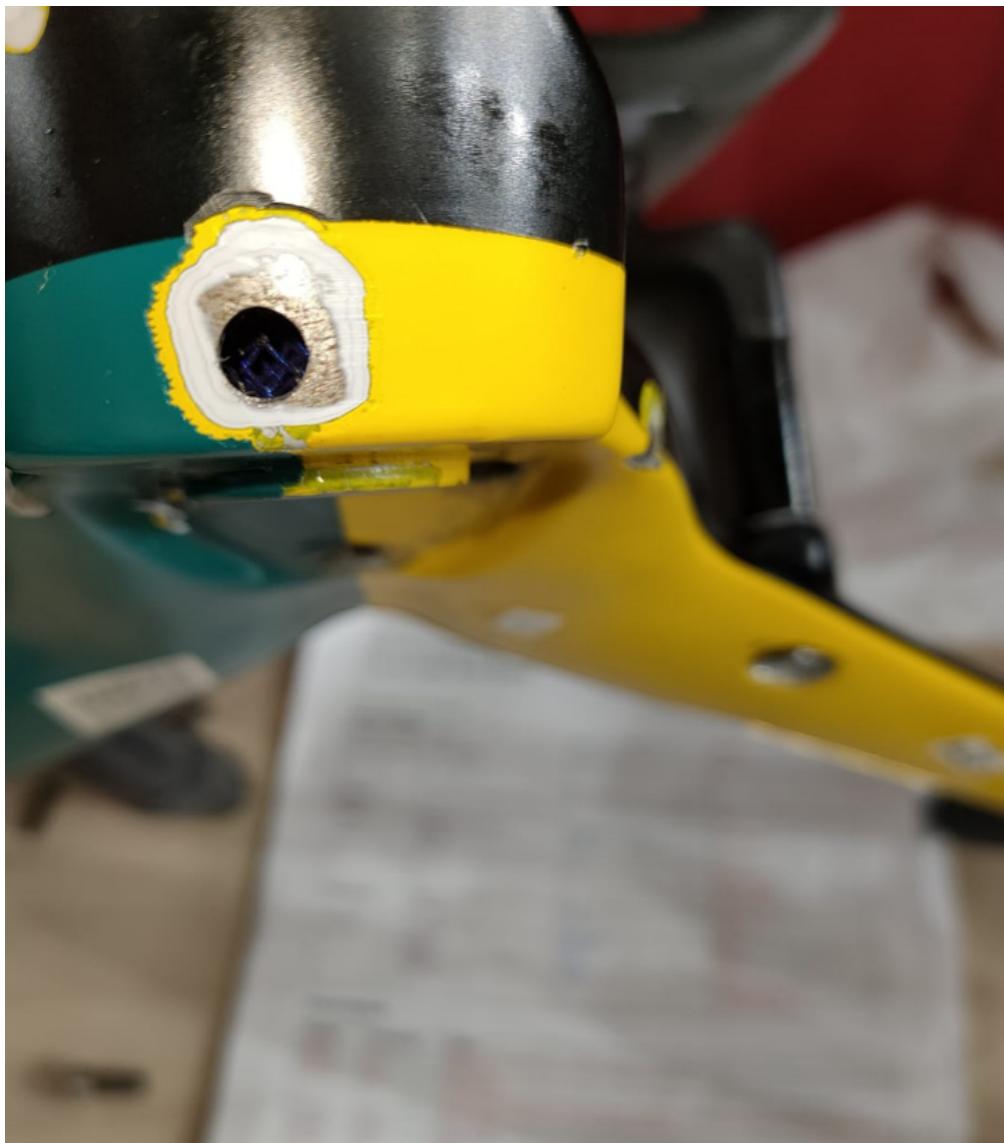
Figure 19 - Bar #1 oxidisation inspection hole

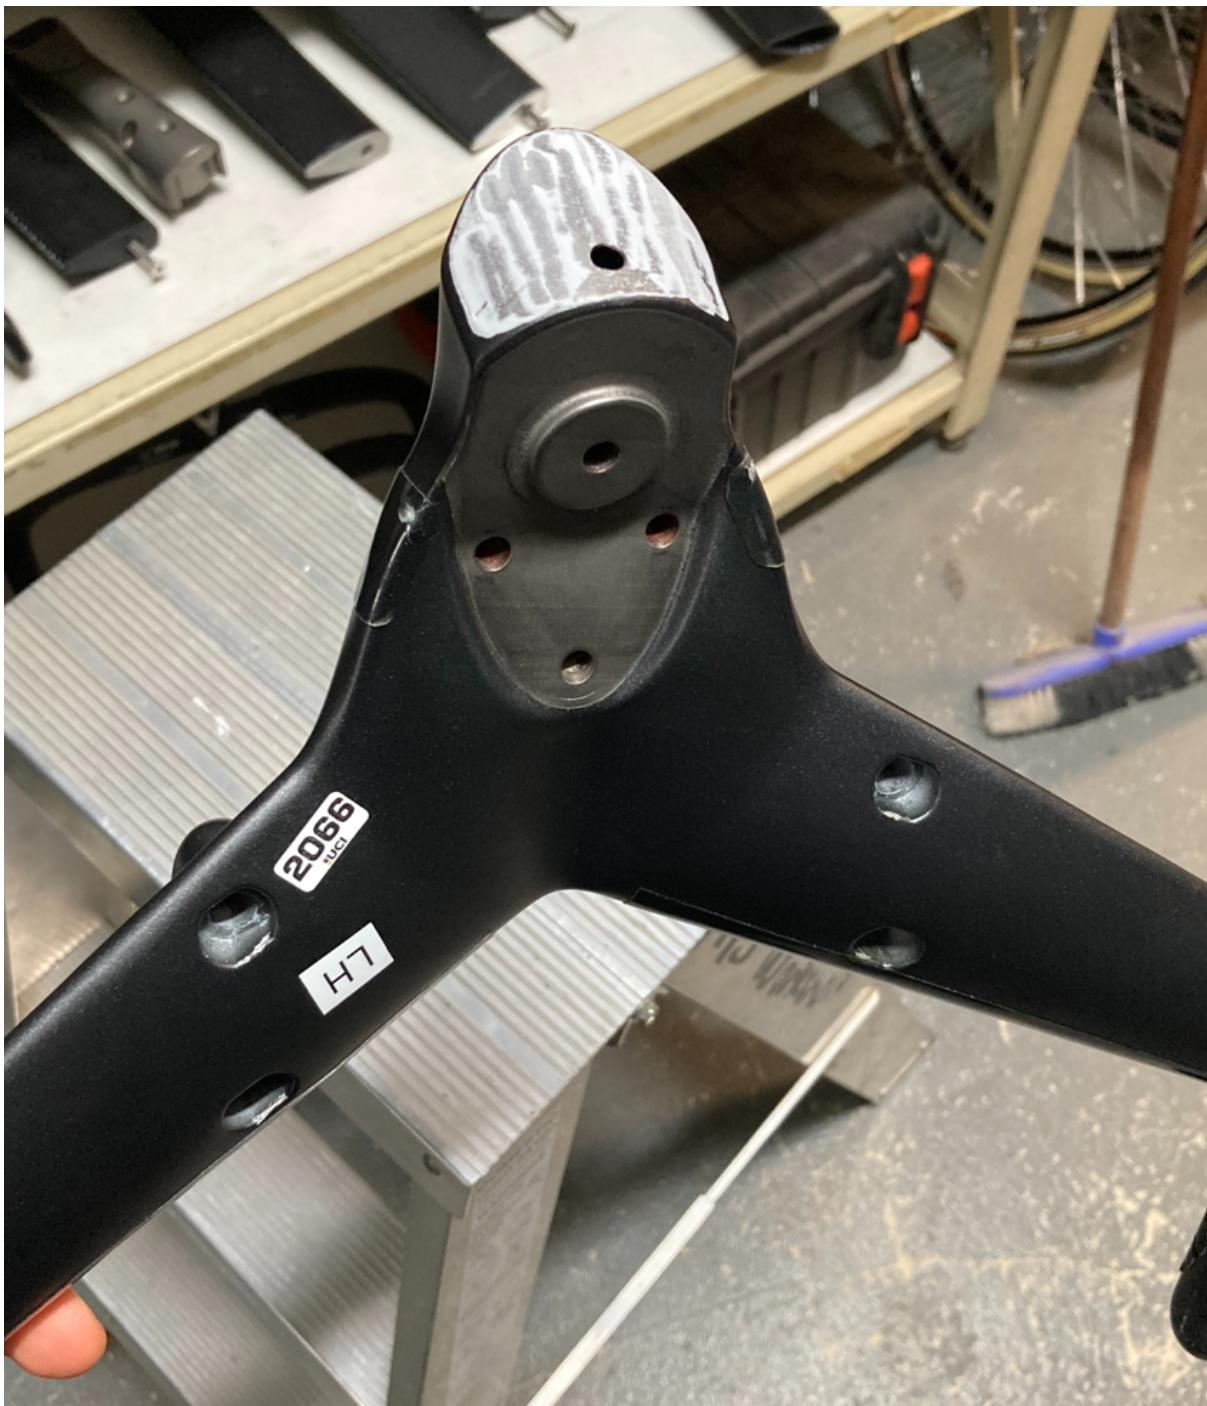
Figure 20 - Bar #2. Used by Leigh Howard in Tokyo. Note there appears to be beginning of crack forming at front of mounting face

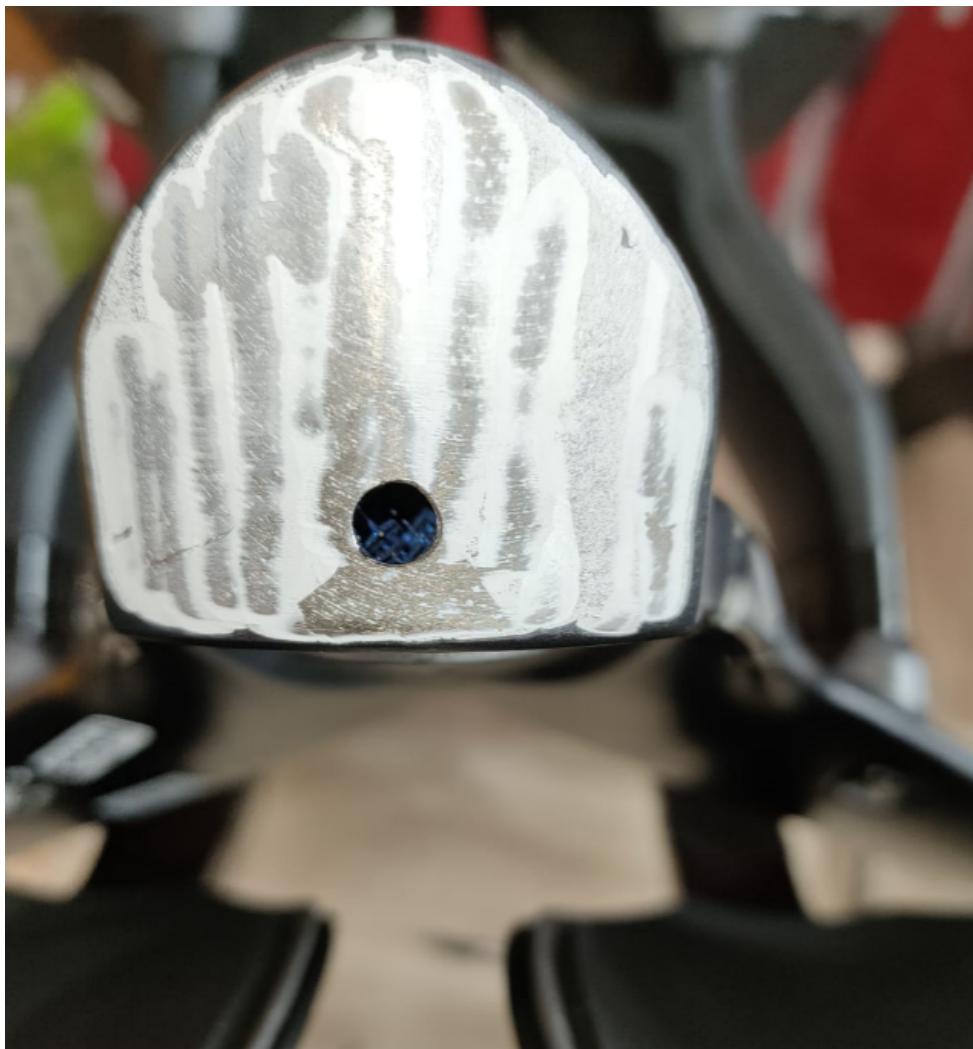
Figure 22 - Bar #2 oxidation inspection hole
