An Investigation into the Handlebar Failure that Occurred in the Australian Men's Team Pursuit race at the Tokyo 2020 Olympics

Date of Incident: 2nd August 2021

Location: Izu Velodrome, Tokyo, Japan

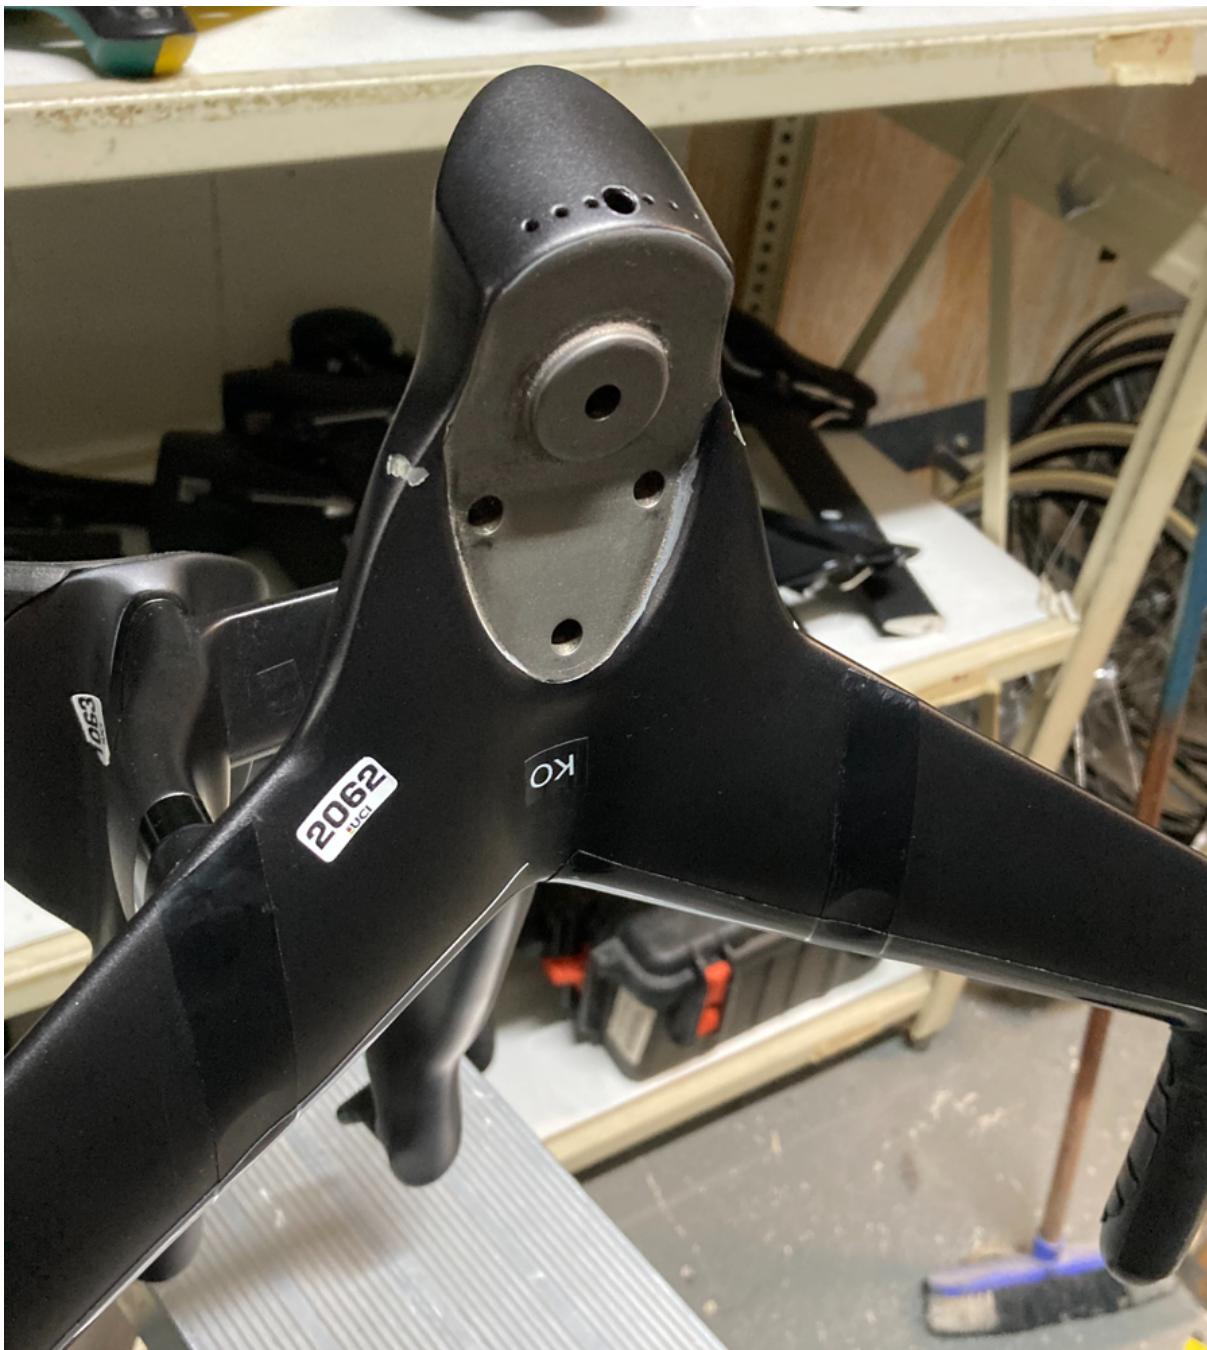
Figure 23 - Bar #3 used by Kell O'Brien in Tokyo

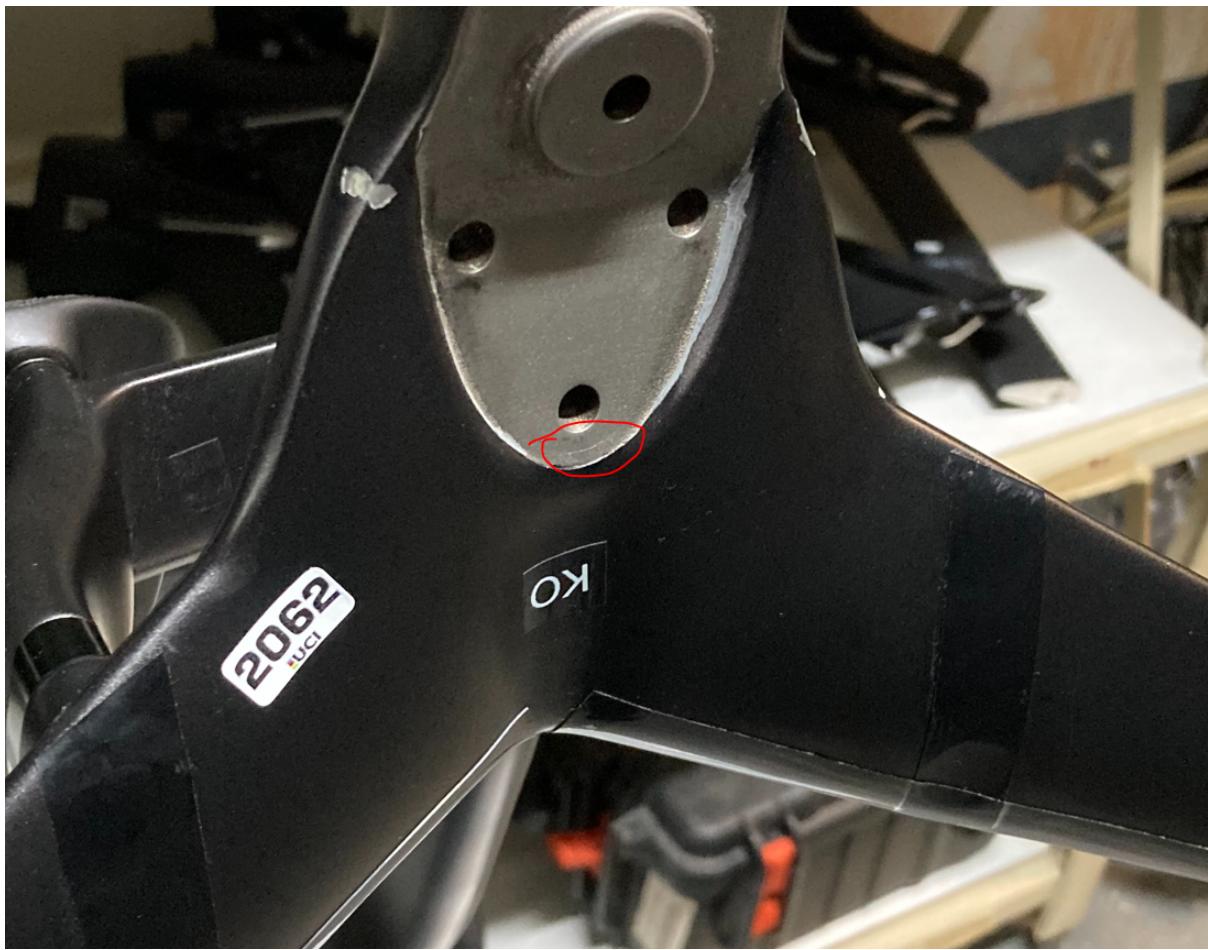
Figure 24 - Apparent crack beginning to form at same location on bar #3

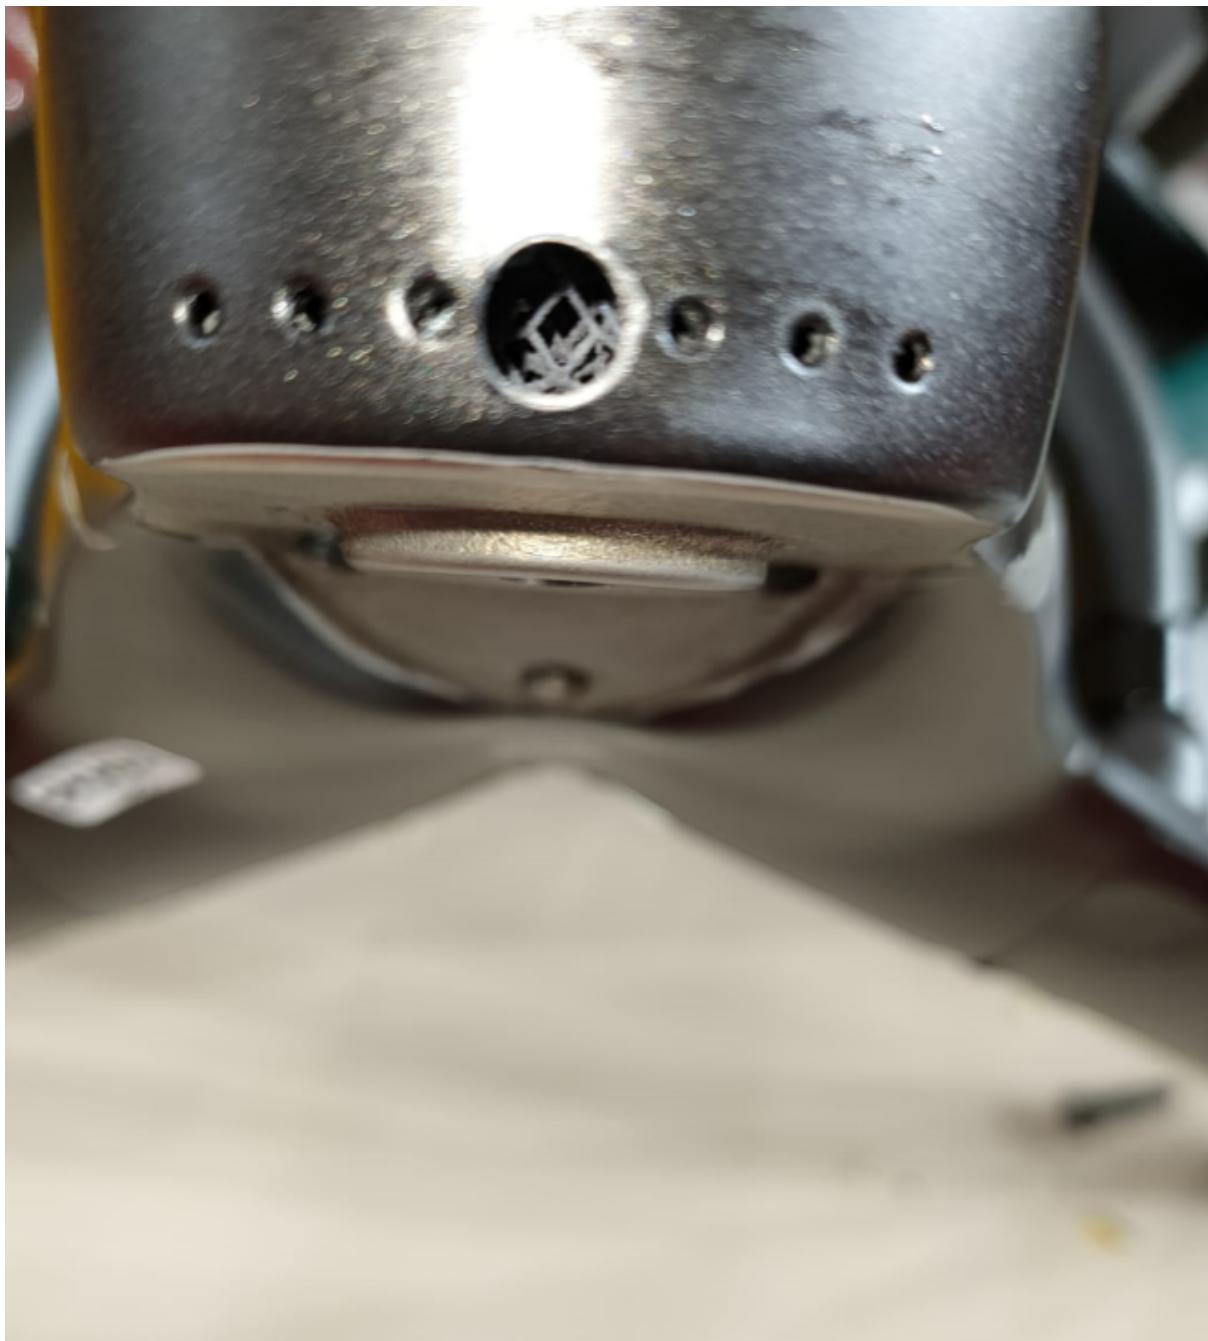
Figure 25 - Bar #3 oxidisation inspection hole

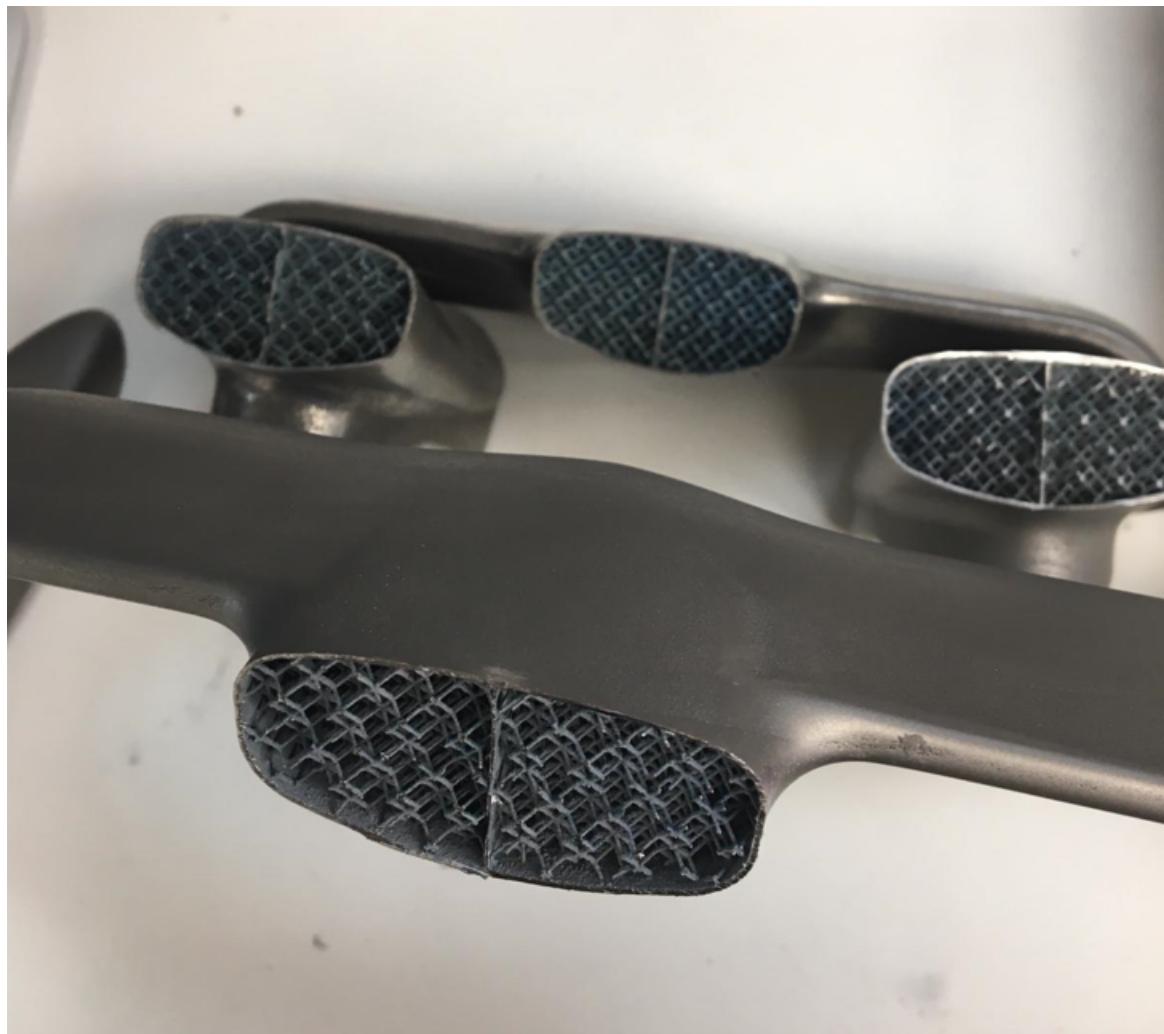
Figure 26 - Cut-through samples of Bastion Madison bars used as example of 'expected' level of oxidisation (ref Bastion)

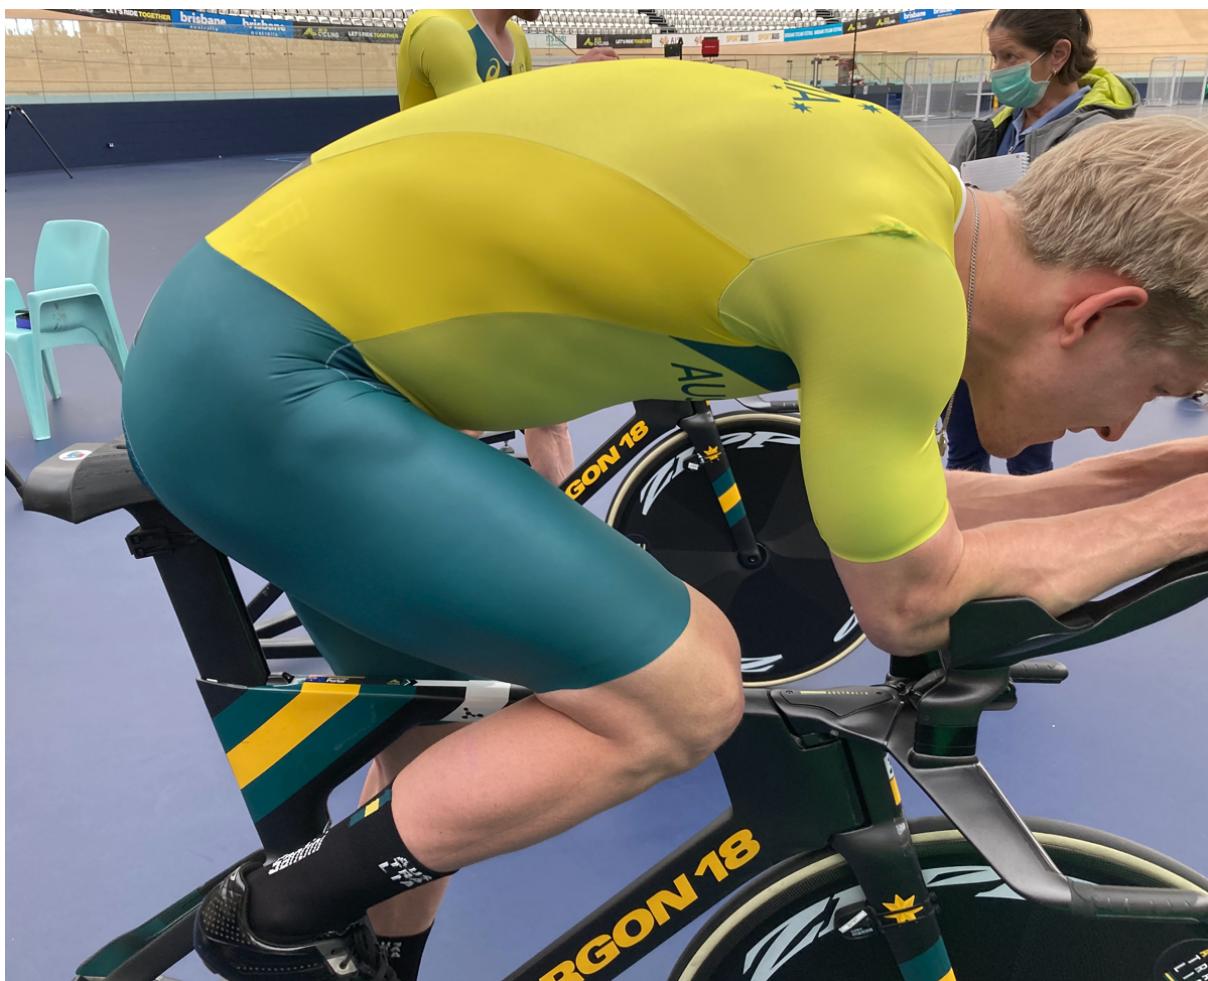
Figure 27 - Alex Porter during skinsuit fitting session in Brisbane, on Tokyo cockpit assembly

Two types of loading cases considered, relevant to different phases of the race:

- 1) – ‘Pull-up’ load – where athlete performs a standing start and is pulling up on the outboard base bar grips (Figure 3), reacting the forces through the pedal.
- 2) – Vertical load downwards through pursuit extensions. The proportion of their mass not supported by the saddle is supported by the pursuit extensions. The riders vary in how much they pull up on the hand grips when in this position, so the sign of the moment about the base bar may be positive or negative. Further, there is additional centrifugal loading when going around the velodrome banking.

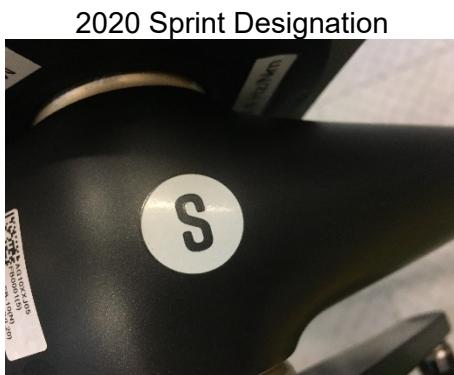
Figure 1: Under bottom bracket frame identifiers

- If the frame and fork has already completed the delivery checks in Section 1.1, progress to the *Section 1.2*.
- Remove all packaging and inspect the parts for any damage which may have occurred during shipping, or visual defects from the factory.
- Confirm frame size and layup (HV if sprint configuration) match on frame stickers and serial number (lower seat tube and under BB).
- 2020 sprint framesets will have an 'S' marked in a white circle under the bottom bracket shell.

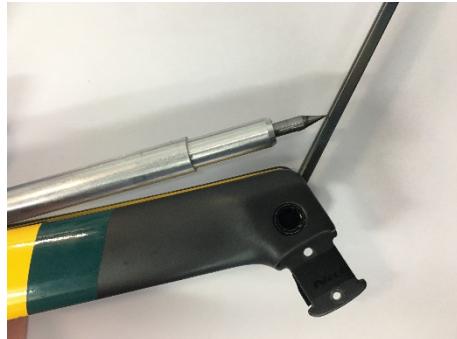
Figure 2: Measuring fork alignment

- C1) Check Lateral alignment of fork top plate (using Jig A, see *Figure 2*). the point on the end of the rod attached to the steerer must be within **+/- 2 mm** from the centreline of the jig to be accepted.
- Weigh the bare frame and fork separately using accurate scales.
- Enter weight, serial number, size, pass/fail of C1, rider allocation into EZOfficeInventory, see *Stock Controller, Andy Rogers*.

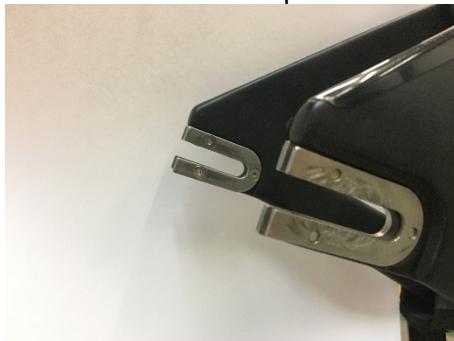
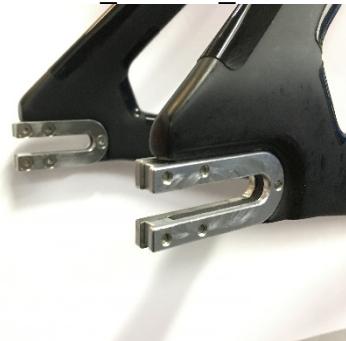
CA-ACT-E-02-002_RETRO_DROPOUT

Figure 3: Comparison of Dropout Plate Assemblies.

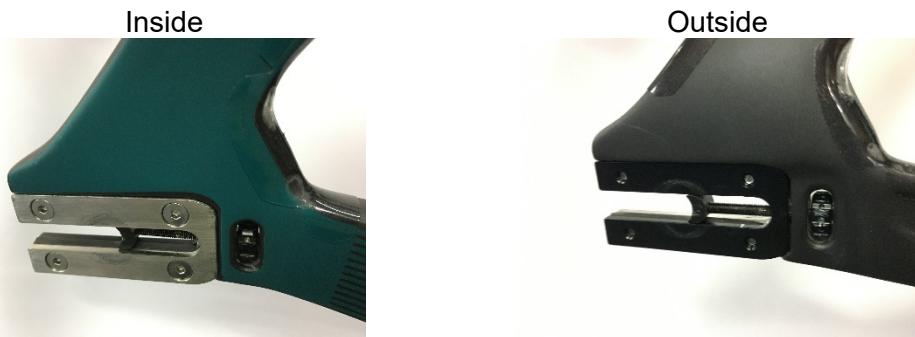
Figure 4: 2020 Dropout Plate Orientation

- If the dropout plates are fitted to the frame on delivery, remove each screw (2.5 mm Hex) one at a time, and apply a small amount of *Loctite 243* to the threads. Reinstall the screws and torque to **1.5 Nm**.
- Unscrew each dropout adjuster all the way, being careful not to lose the dial when the threaded rod is removed. Run a small bead of *light chain lube* along the length of the thread and reinstall, ensuring the thread turns freely and the half-moon part fully returns. The half moon section should not overhang the sides of the dropout plate, if this is the case, unscrew and rotate **180 deg** to ensure clearance on both sides.

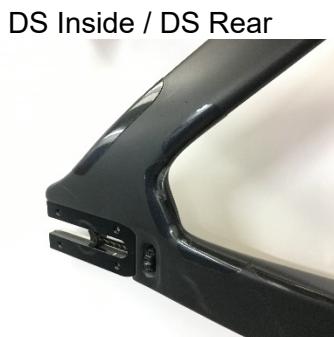
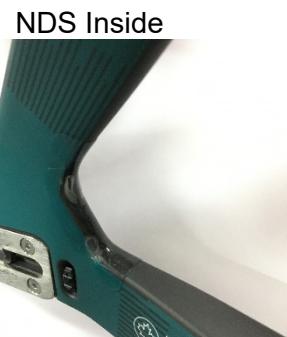
Figure 5: Positioning of Protective Frame Stickers

- Using **3M 8591 tape** and the cutting template at Appendix A, cut sections to size, making intermediate cuts where marked. All corners should be rounded with a radius of approximately **5 mm** and placed with the specifications on the template.
- Ensure the frame surface where the stickers will be placed is clean and free of grease, dust and contaminants by wiping with **Isopropyl wipe** and allowing to dry.
- Follow the references on the cutting guide and *Figure 5*.

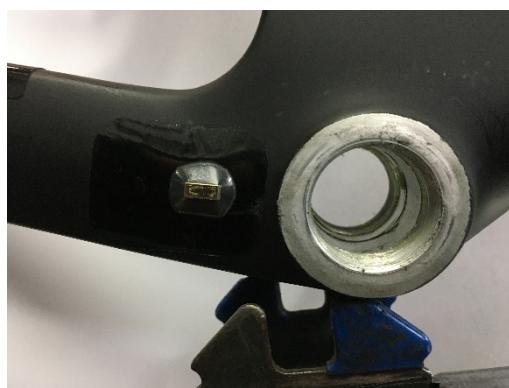
- Using a 40 x 20 mm rectangle of **3M 8591 tape** position the small rectangular magnet horizontally on the left of the drive-side of the bottom bracket shell, **40 mm** from the centre of the shell.

Figure 6: Correctly positioned SRM Magnet.

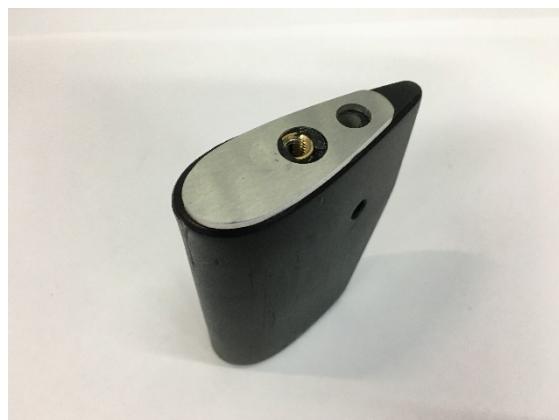
Figure 7: Original version of 2018 Electron Pro Seat Tube Blocker

- Collect the correct length blocker for the frame, listed in *Table 6*. These are referred to by the CA ACT Engineering part numbers CA-ACT-E02-006-04P to -07P, refer to the drawing at *Appendix D* or as per *Figure 7*.
- Drop this part down the seat tube, check it is resting on the rear wheel cut-out on the back face of the seat tube at the height of the seat stays. It may require to be pushed through the controlled diameter section; the part will sit loose in the frame.

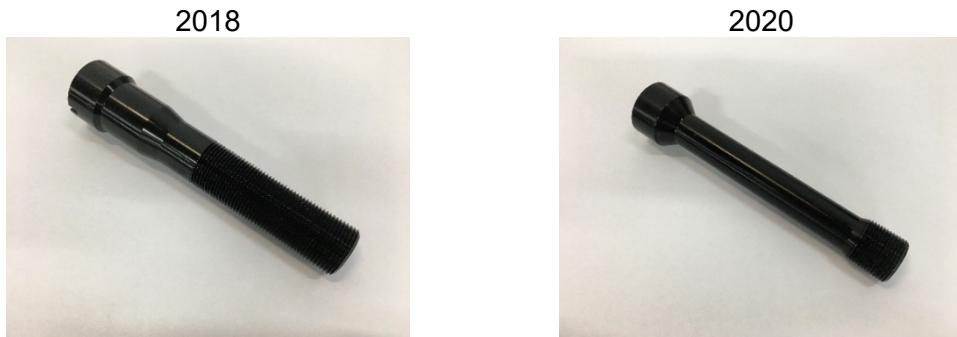
Figure 9: Comparison of Steerer Tube Components

- The 2018 steerer tube can only be installed using the 19.5mm 3D Headtube Tool.
- The 2020 steerer tube can only be installed using an 8 mm Hex.

ATTENTION: There are two different versions of steerer tube for the relevant model year frames, care should be taken to ensure the correct one is selected.

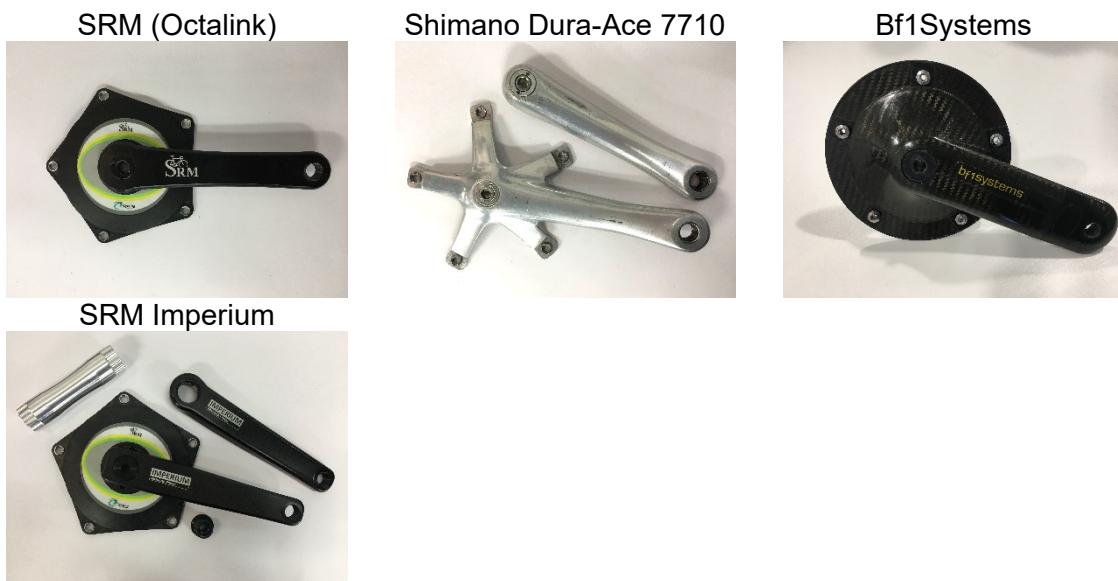
Figure 10: Example Images of Cranksets

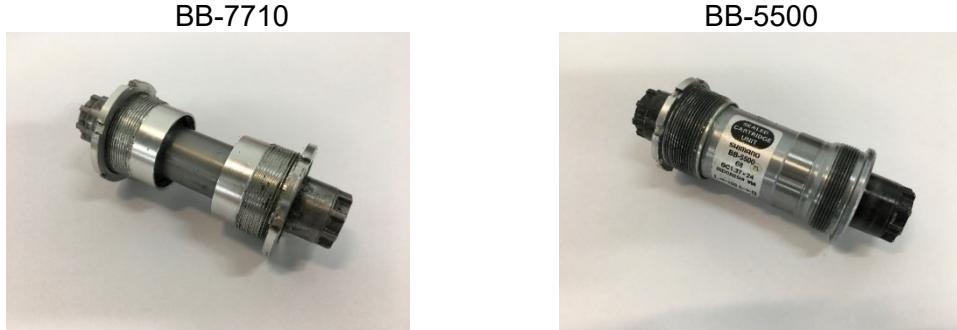
Figure 11: Comparison of Shimano Octalink Bottom Brackets

- The tools required are dependent on the model of bottom bracket being installed, see *Figure 11*.

- Note: The central sleeve with model and orientation markings is not required and is not pictured in *Figure 11*.
- Separate the non-drive-side cup from the drive-side and spindle.

- Cranksets requiring an internal bearing bottom bracket as selected in Section 2.2.1 and shown in *Figure 11*.

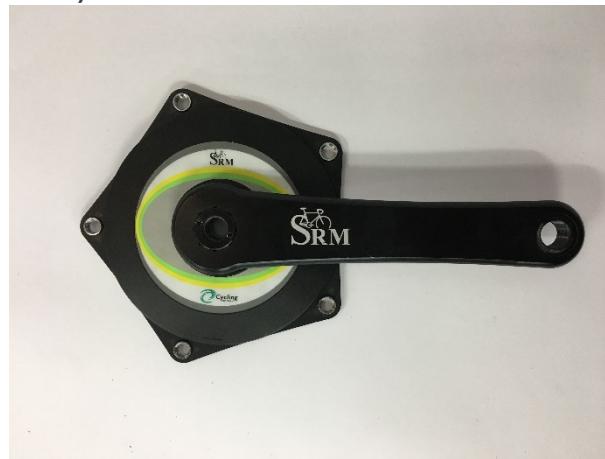
Figure 13: SRM Octalink Crankset

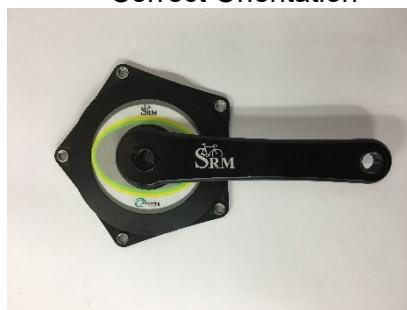
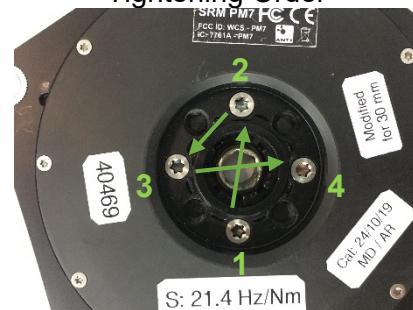
Figure 14: Correctly positioned and tightened SRM plate.

- Align the SRM Plate onto the crank-arm, using 4x *SRM Plate Screws*, clean the screws threads with *acetone*, apply *Loctite 243* and tighten the bolts (T25) to **5 Nm**.

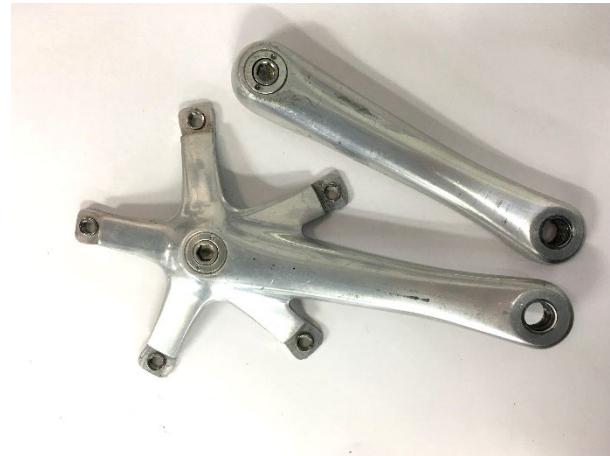
Figure 15: Shimano Dura-Ace 7710 Crankset

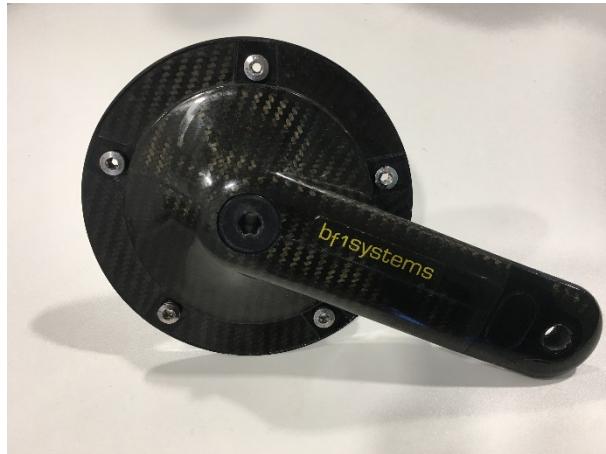
Figure 16: Bf1Systems Crankset

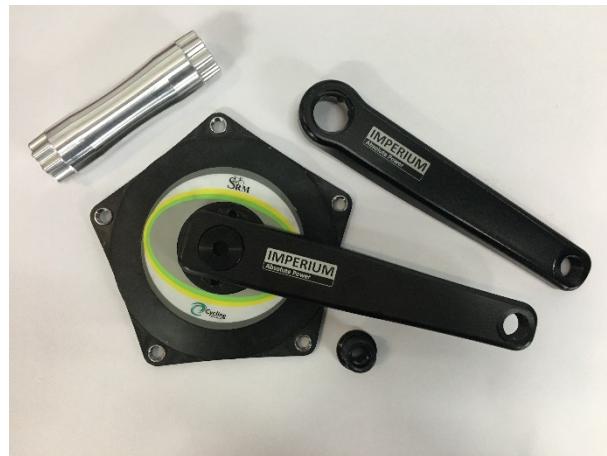
Figure 18: SRM Imperium Crankset.

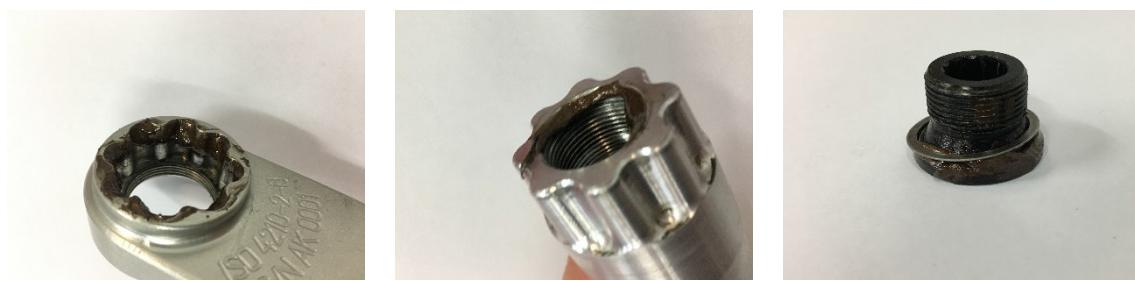
Figure 19: Correct application of copper anti-seize for Imperium crank.

- External bearing cranksets will require the BB386 Bottom Bracket installed in *Section 2.2.2* and shown in *Figure 12*.
- Ensure the appropriate length crank arms have been selected for the rider and each crank arm is the same length.
- Apply a small amount of *Copper anti-seize* into the notches in the non-drive-side crank arm and the threads in both sides of the crank spindle. As well as the shoulder of the crank bolt on which the washer sits and the washer itself per *Figure 19*.

- Apply *Copper anti-seize* to the crankarm and crank bolt as per *Figure 19*.
- Fit the crankarm into the notches of the spindle and ensure the crankarms are parallel. Fit the washer over the crank bolt and thread the bolt into the spindle. Smoothly tighten the bolt (10 mm Hex) to **40 Nm**.

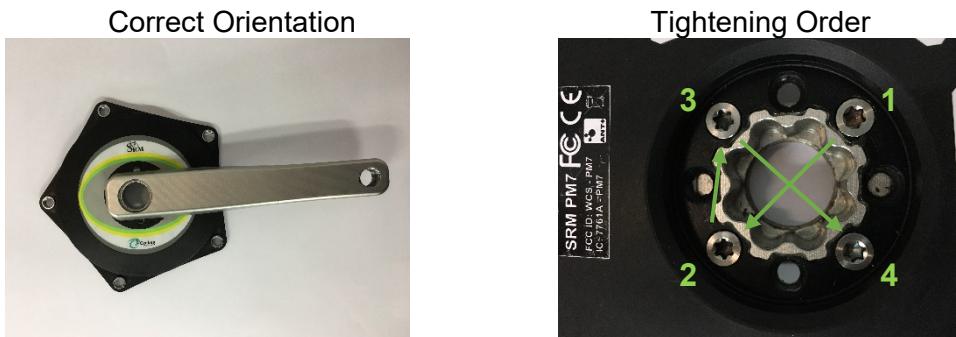
Figure 20: Correctly positioned and tightened SRM plate.

- Thread in the plate screws until finger tight (T25 Torx), then in 1/8th of a turn increments diagonally across the plate (see *Figure 20*), tighten to **5.5 Nm**.

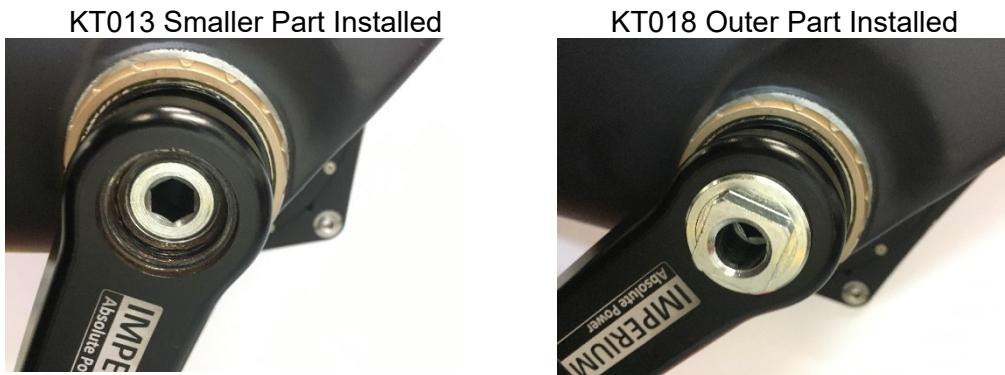
Figure 21: Extracting Imperium crankarm using Cannondale KT013

- To extract the crankarm, remove the non-drive-side crank bolt (10 mm Hex), thread in the smaller part of the Cannondale KT013 (8 mm Hex) such that it sits below flush in the axle.

- Thread in the larger part of the Cannondale KT013 and tighten (15 mm Open-Ended Wrench) into the crank arm, unwind the part threaded into the axle against the outer (8 mm Hex) to remove the crank arm from the spindle.

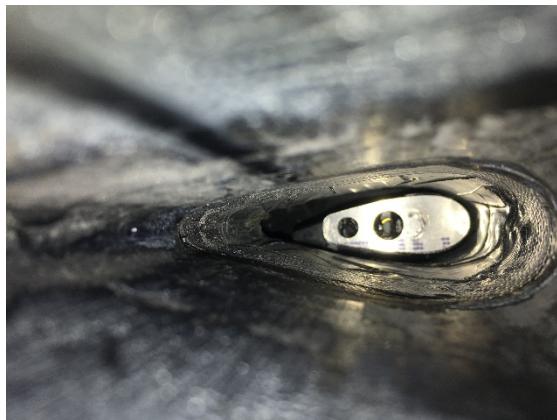
- A seat tube blocker should have been installed in *Section 1.4* and appear as so:

Figure 22: Correctly installed Seat Tube Plug in 2018 Frameset

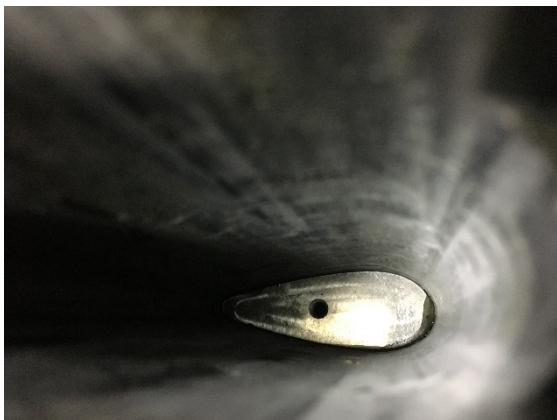
- A seat tube plug should have been installed in *Section 1.4* and appear as so:

Figure 23: Correctly installed Seat Tube Plug in 2020 Frameset

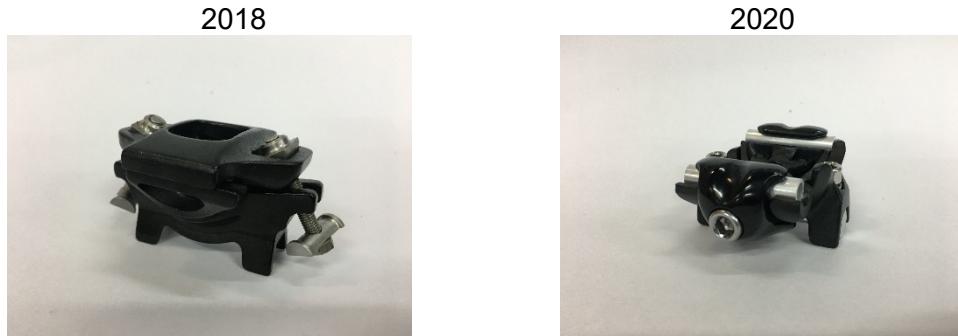
- For the 2020 framesets, a different seat clamp was selected to save weight, however the clamps are cross compatible if required.

Figure 24: Comparison of 2018 and 2020 seat clamps

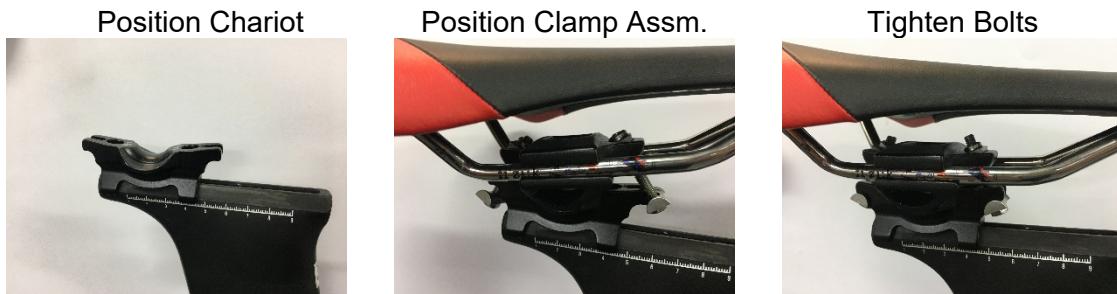
- Use the 8 mm Open End & Ring Spanner to tighten the two bolts equally, using the ring-end of the spanner if accessible, until the bolts are firm.
- Flex the seat as firmly as possible to bed-in the assembly, check and readjust the seat angle and setback as necessary until the seat no longer moves. This step may also be necessary after the bike has been ridden for the first time.

Figure 25: 2018 Seat Clamp Assembly Steps

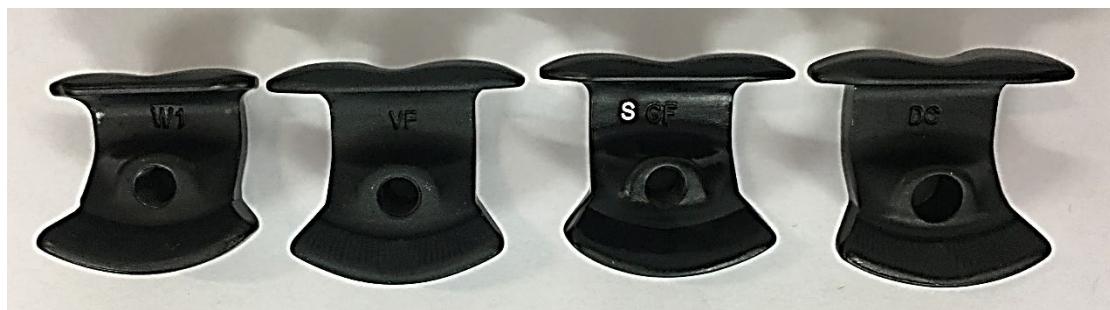
- Seat clamps supplied with 2020 Electron Pro Framesets require different ears depending on the different size seat rails. It is important to measure the dimensions of the seat clamp rails to ensure the correct ears for the seat clamp have been selected, ears with serrations on the inside are best to prevent slipping.

Figure 26: Seat Clamp Ear Markings

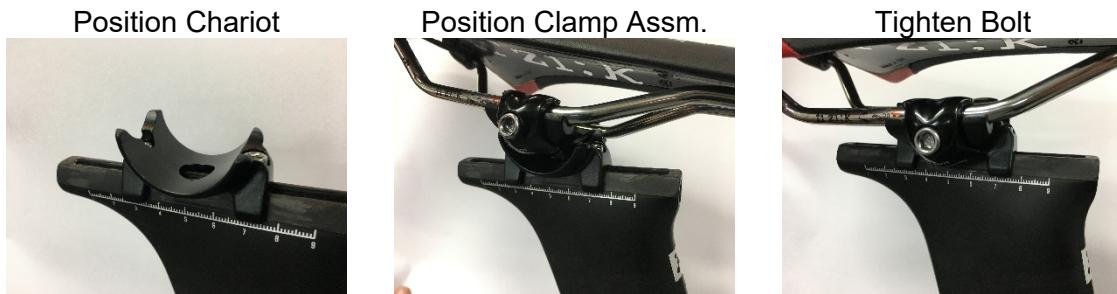
- Slide the *shuttle* through the front of the slot in the top of the seatpost and place the *chariot* on top, aligning the screws with the threads in the shuttle and position in the middle of the slot. Tighten the two screws (4 mm Hex) to **6 Nm**.
- Install the ears into the clamp assembly with the bolt head for tightening on the drive-side of the bike, tighten the bolt (5 mm Hex) **two turns**.
- Position the clamp assembly on the chariot and hook one ear at a time over the lip on the chariot.
- Position the seat per *Section 3.5* and tighten the clamp (5 mm Hex) to **16 Nm**.

Figure 27: 2020 Seat Clamp Assembly Steps

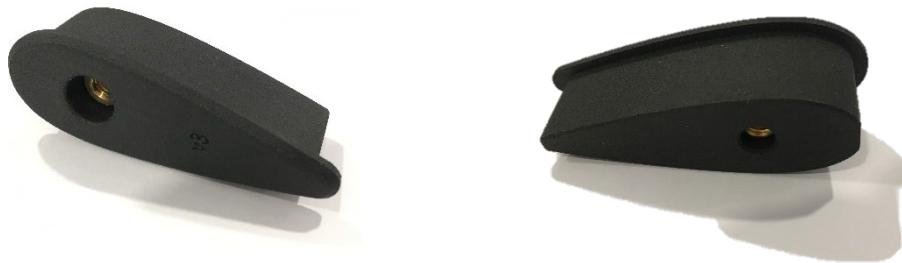
- The latest specification of post plug is marked 'v3' on the underside and has a counterbore for the bolt head and has internal part *number CA-ACT-E02-006-03P_2018_Argon_18_Seat_post_blocker_V3*.

Figure 29: 2018 Seat Post Plug

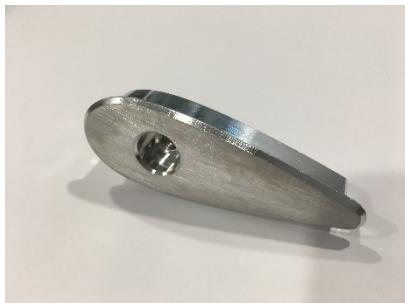
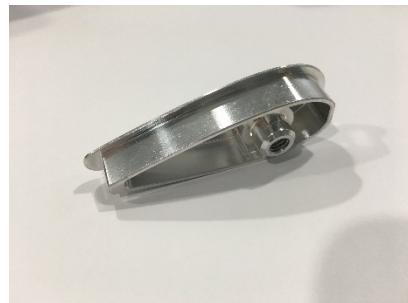
- The bolt supplied is a loose fit in the thread and can move easily, it is recommended *Loctite 243* or *Teflon Tape* be applied to the thread of the bolt to ensure the bolt can't move during use or in transit.

Figure 30: 2020 Seat Post Plug

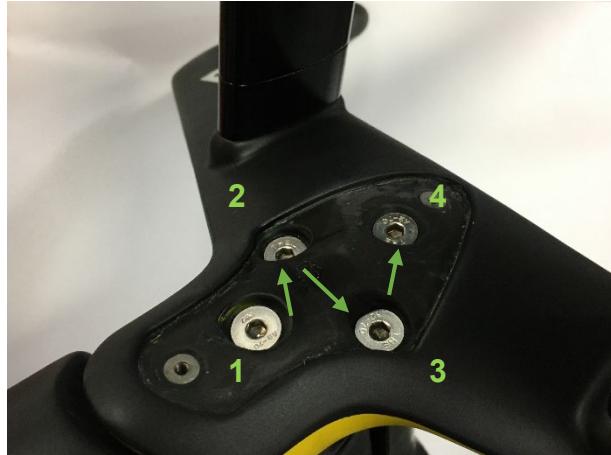
- Follow the correct fastening order in *Figure 32* and tighten the screws (4 mm Hex) to approximately **5 Nm** and then to **8 Nm**.
- Repeat this fastening order at until the torque wrench clicks off on all four bolts without the bolts turning any further.

Figure 32: Correct fastening order of pursuit basebar bolts.

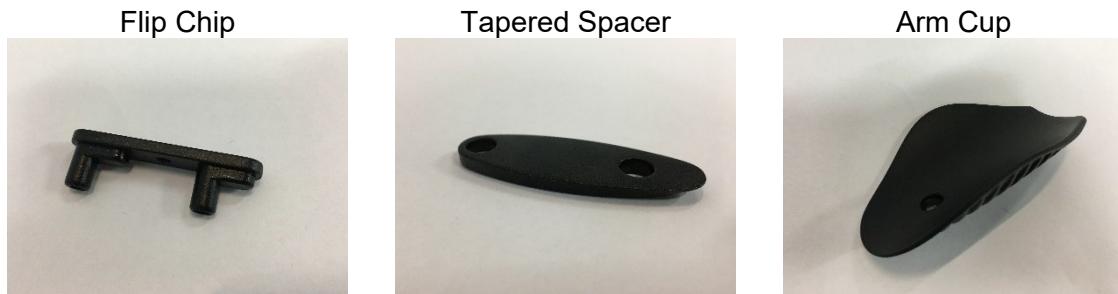
- Integrated pursuit extensions require several different pieces of hardware which are shown in *Figure 34* and listed in *Table 28*. Pay careful attention to the orientation of the flip chip and tapered spacer and its effect on the extension length and note the arm cups are different from left to right.

Figure 34: Components Specific to Integrated Pursuit Extensions

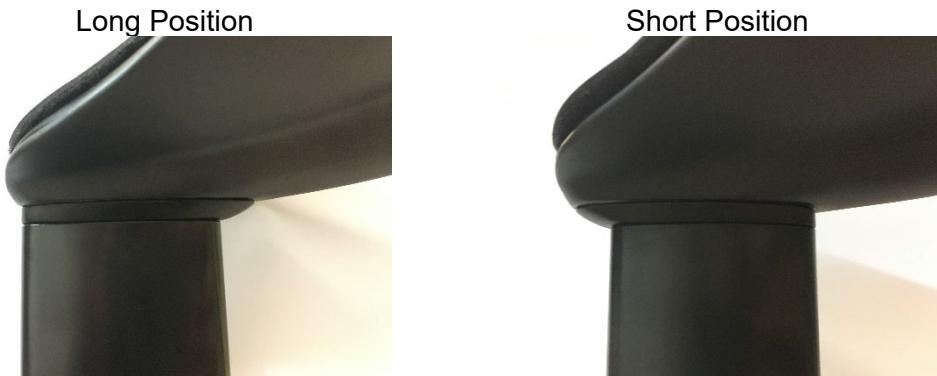
- Position the *tapered spacer* such that if the extension is to be installed in the long position, the long overhang is at the front and vice-versa. If the part looks out of place, it may be oriented incorrectly, check both orientations.

Figure 35: Flip Chip and tapered spacer orientations.

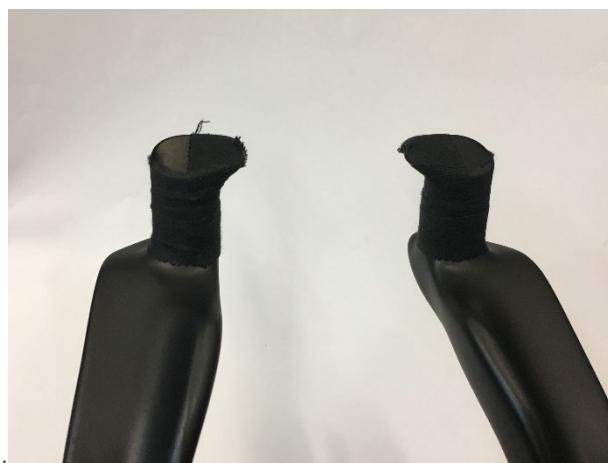
- If no Velcro and foam has been installed, apply the piece of self-adhesive Velcro (check the piece is on the correct side cup).
- Drop the M5 x 12 mm FHCS screw into the countersink on the centreline of the arm cup. Position the cup, carefully checking alignment and torque to **5 Nm (3 mm Hex)**.

Figure 36: Correct Extension Orientation

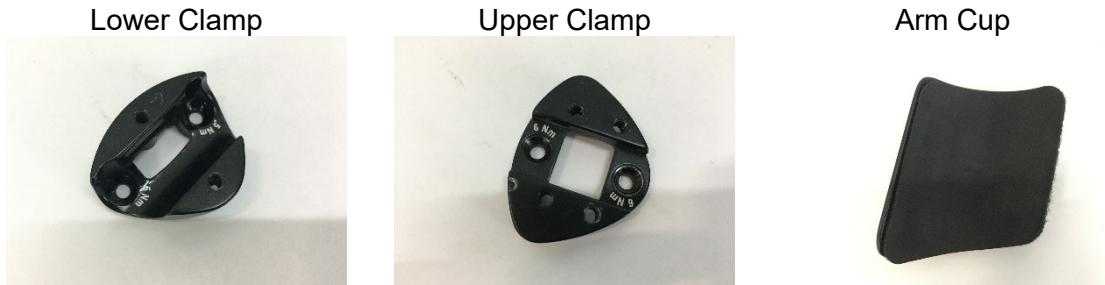
Figure 37: Components Specific to Standard Pursuit Extensions

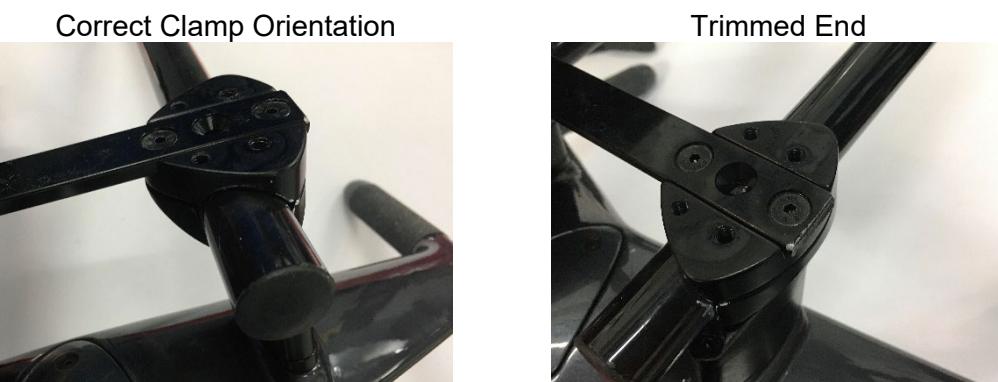
- Grease the *4x M5 x 18 mm* as above and drop them into outer- and innermost countersinks in the bridge, position the *Upper Clamp* parts as pictured below. Only screw the screws into the *Lower Clamp* two turns.

Figure 38: Upper Clamp Assembly.

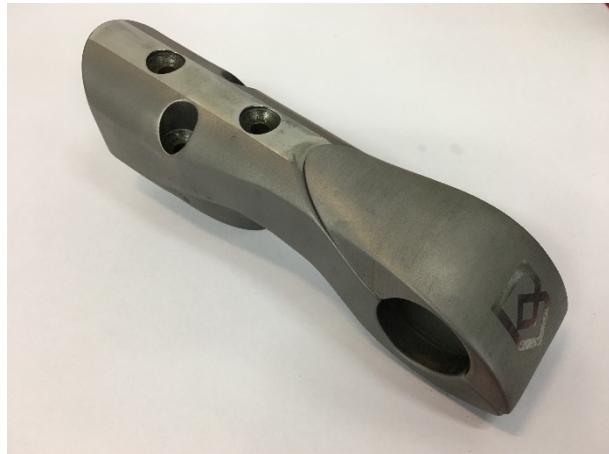
Figure 39: Bastion Sprint Stem

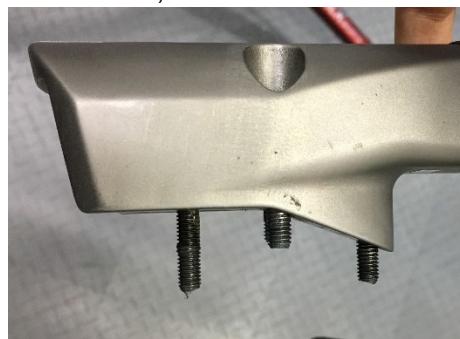
- The bolt lengths should allow **10 mm** of protrusion of the front three *M6 Countersunk bolts* and, for the 2018 bike - **20 mm**, for the 2020 bike – **30 mm**.

Figure 41: Adequate bolt length for 2018 Electron Pro

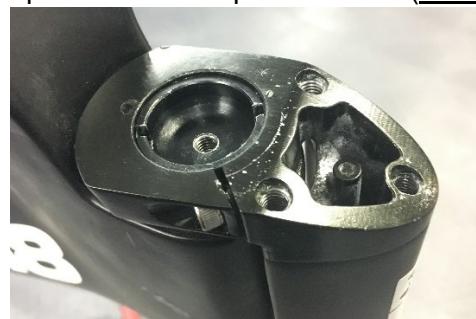
- Ensure the top surface of the fork is clean and free of debris. Check the headset is not loose and the steerer pinch bolt is torqued to **5 Nm (4 mm)**.

Figure 42: The Electron Pro fork interface.

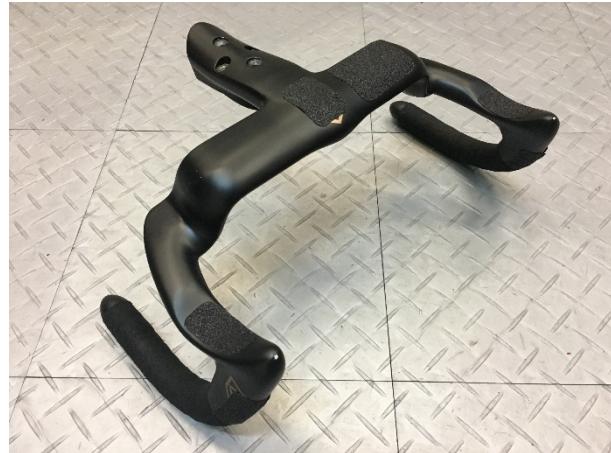
Figure 45: Bastion Madison Handlebar

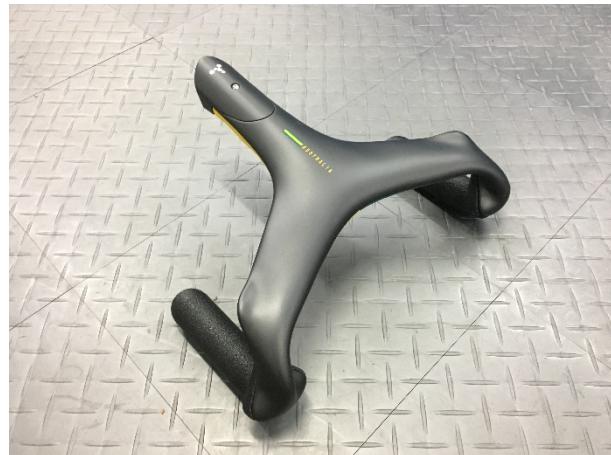
Figure 46: Argon 18 Integrated Sprint Handlebars

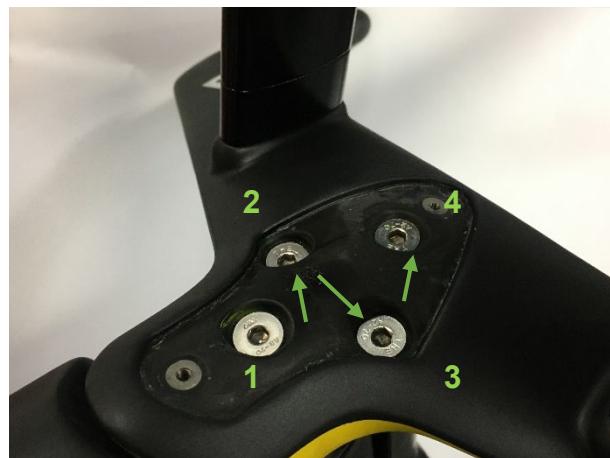
- Apply a small amount of *Aquaproof grease* to the thread and underside of the head of the 4x *M6 FHCS* screws.
- Thread in the centre bolt, ensure the handlebar is correctly aligned and finger tighten the bolt. Install the three remaining bolts and finger tighten.
- In the order depicted in *Figure 47*, tighten the bolts in 1/8th turn increments (4 mm Hex) to **8 Nm**.

Figure 47: Correct fastening order of integrated sprint bar bolts.

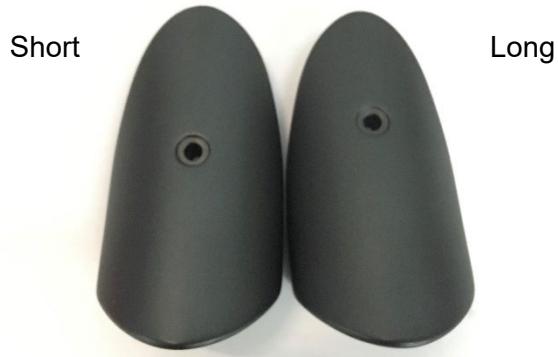
Figure 48: Versions of Integrated Bar Cap.

- The two versions of the handlebar require two different covers, the versions are identified in *Figure 48*.
- Apply a small amount of *Aquaproof grease* to the threads of the *M4 button-head* screw and finger tighten (2.5 mm Hex).

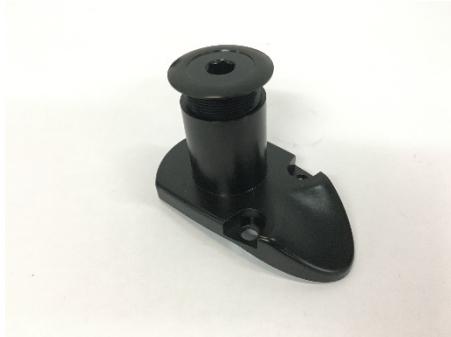
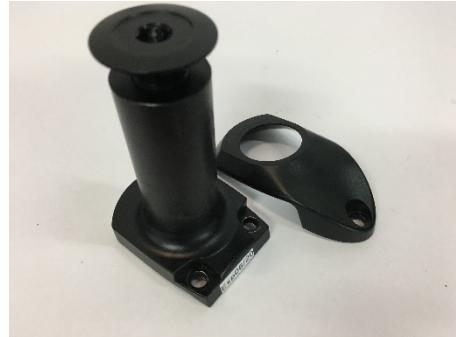
Figure 49: Versions of Steerer Module

ATTENTION: Only Version 2 of the steerer module can be used on any bicycle, if found, Version 1 modules must be destroyed.

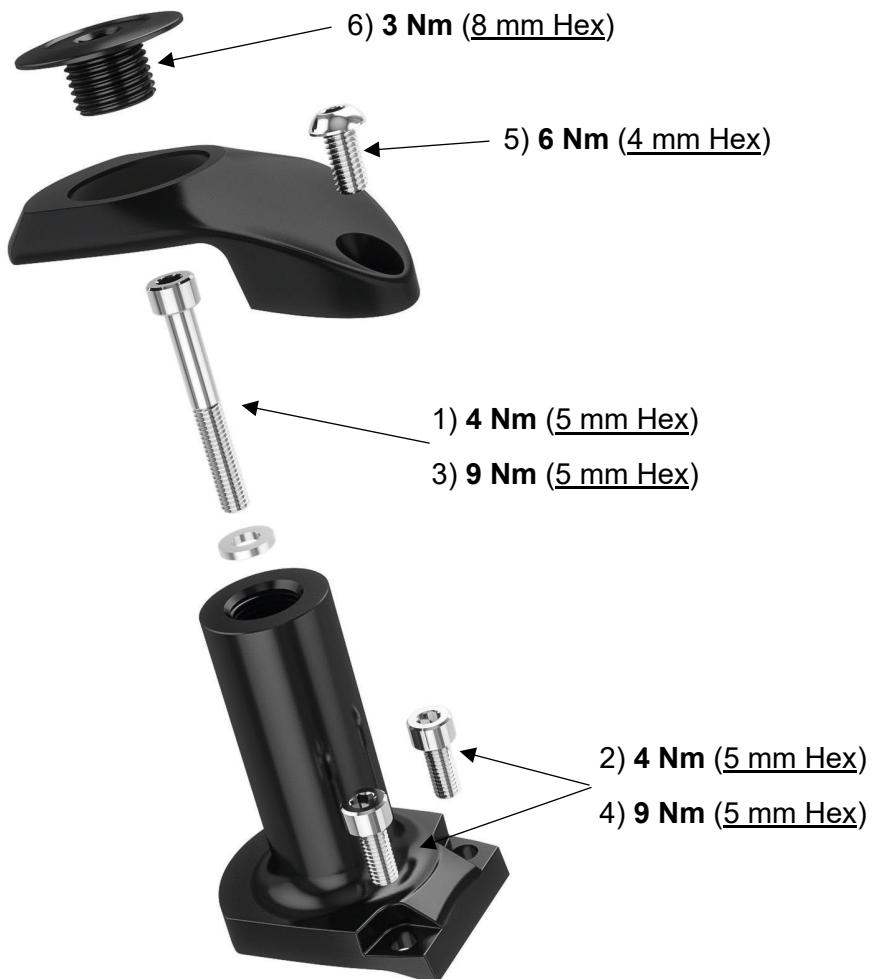
- Check the expiry date marked on the front and/or rear of the module's base and, if unsure, check with the Stock Controller about the safety of the part.
- Unscrew the top-cap and set aside.
- Apply a small amount of grease to the underside of the heads and the threads of the 3x M6 Socket Head screws and fit the washer to the **45 mm** screw.
- Drop the **45 mm** screw down the centre of the tube and align the *Steerer Module* in position on top of the fork, tighten to **4 Nm (5 mm Hex)**.
- Thread in the two front screws and tighten to **4 Nm (5 mm Hex)**.
- Starting at the screw in the centre of the steerer tube, tighten the three screws in $\frac{1}{4}$ turn increments (5 mm Hex) to **9 Nm**.

Figure 50: Steerer Module Assembly Order
