An Investigation into the Handlebar Failure that Occurred in the Australian Men's Team Pursuit race at the Tokyo 2020 Olympics

Date of Incident: 2nd August 2021

Location: Izu Velodrome, Tokyo, Japan

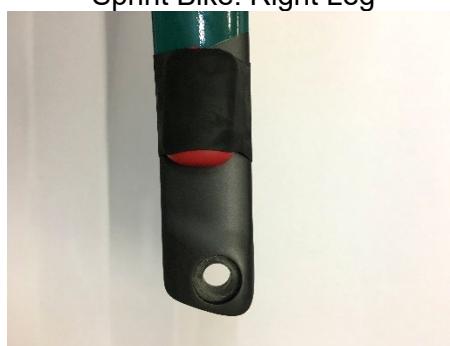
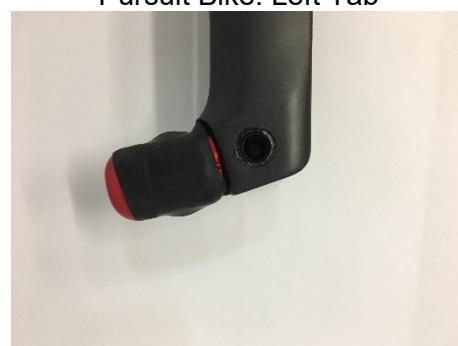
- For pursuit bikes; slide removable cover end of the tag into the tube, with the front wheel removed, slide the tube over the tab on the left fork leg. If using the closed end of the tube, it or the removable cover should face forward and the loops on the side of the tag should align with the slots in the tab. Pull the tube onto the dropout so there are no wrinkles in the tube.

Figure 51: Covered Timing Tag

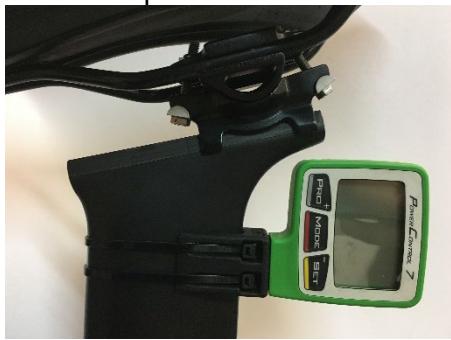
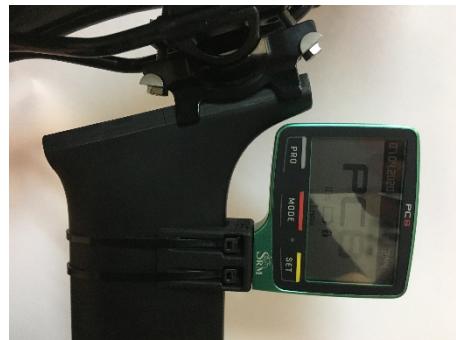
Figure 52: Correct SRM Mount Orientation, NDS View

- The only SRM mounts used should be **CA-ACT-E02-001-03P-v07,X_SRM_SeatPost_Mount**, which have a matte black finish and 'SRM' written on the top and bottom faces.
- Position the mount such that the recesses for the zip tie heads should be on the non-drive-side of the bike and the curved side of the dovetail should face the drive-side.
- For sprint bikes, the mount should be positioned **50 mm** from the top-rear of the seat post as they use smaller SRM PC7 headunits.
- For endurance bikes, the mount should be positioned **60 mm** from the top-rear of the seat post as they use larger SRM PC8 headunits.

Sprint Bike: PC7

Endurance Bike: PC8

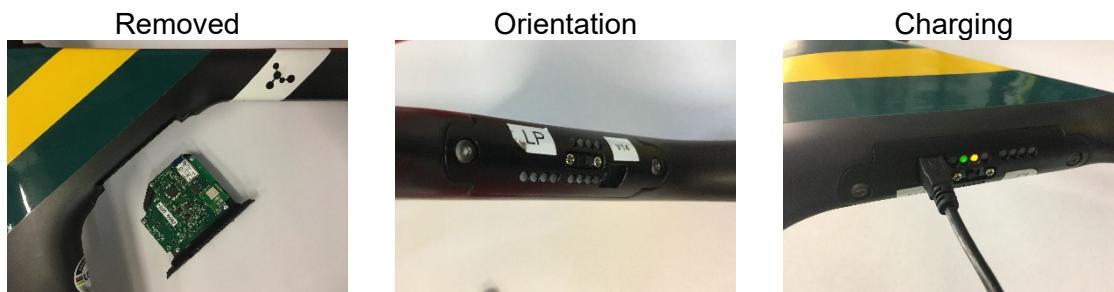
Figure 53: Correct Internal WSL Fitment

ATTENTION: Correct orientation is critical for the system to function correctly

- Evenly tighten the two screws (*2.5 mm Hex*) to **2.5 Nm**.
- If the cradle is oriented upside-down the top edge will produce a lip and the bottom edge will have an undercut to the slight tapered shape of this section of the frame.
- Switch the system on and check a solid light appears, switch the system off and set it on charge using one of the cables installed in the Lower Workshop at the Adelaide Super-Drome or the portable WSL battery system. Check for green and yellow lights to indicate charging.

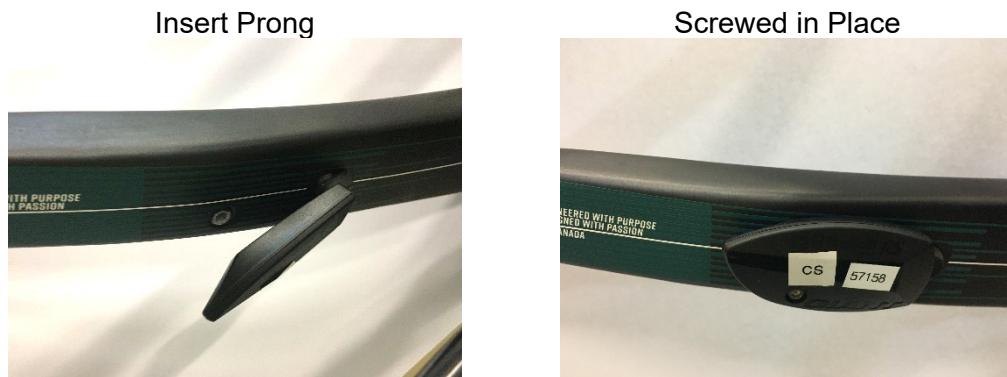
Figure 54: Giant Ride Sense Installation.

- Check a CR2032 battery is installed and not flat by removing the cover on the back-side of the sensor.
- Slot the prong of the sensor in the hole drilled in the non-drive-side chainstay and press the sensor flat against the chainstay.
- Insert the *M3 x 14 mm* screw, supplied with the sensor or a screw of similar dimensions, into the hole in the sensor and rotate the sensor until the screw pushes into the nutsert in the frame.
- Tighten the screw (2.5 mm Hex) to **2 Nm** and check for play in the sensor.
- If the sensor is being installed for the first time or as a replacement, inform the *Performance Systems Manager, Andy Warr*.
